**ARCHAEOLOGICAL INVESTIGATIONS AT  
GUNSTON HALL PLANTATION  
(44FX113)**

**Report on 2011 Activities**

**GUNSTON HALL PLANTATION  
Archaeology Department  
Mason Neck, Virginia**

**March 2012**

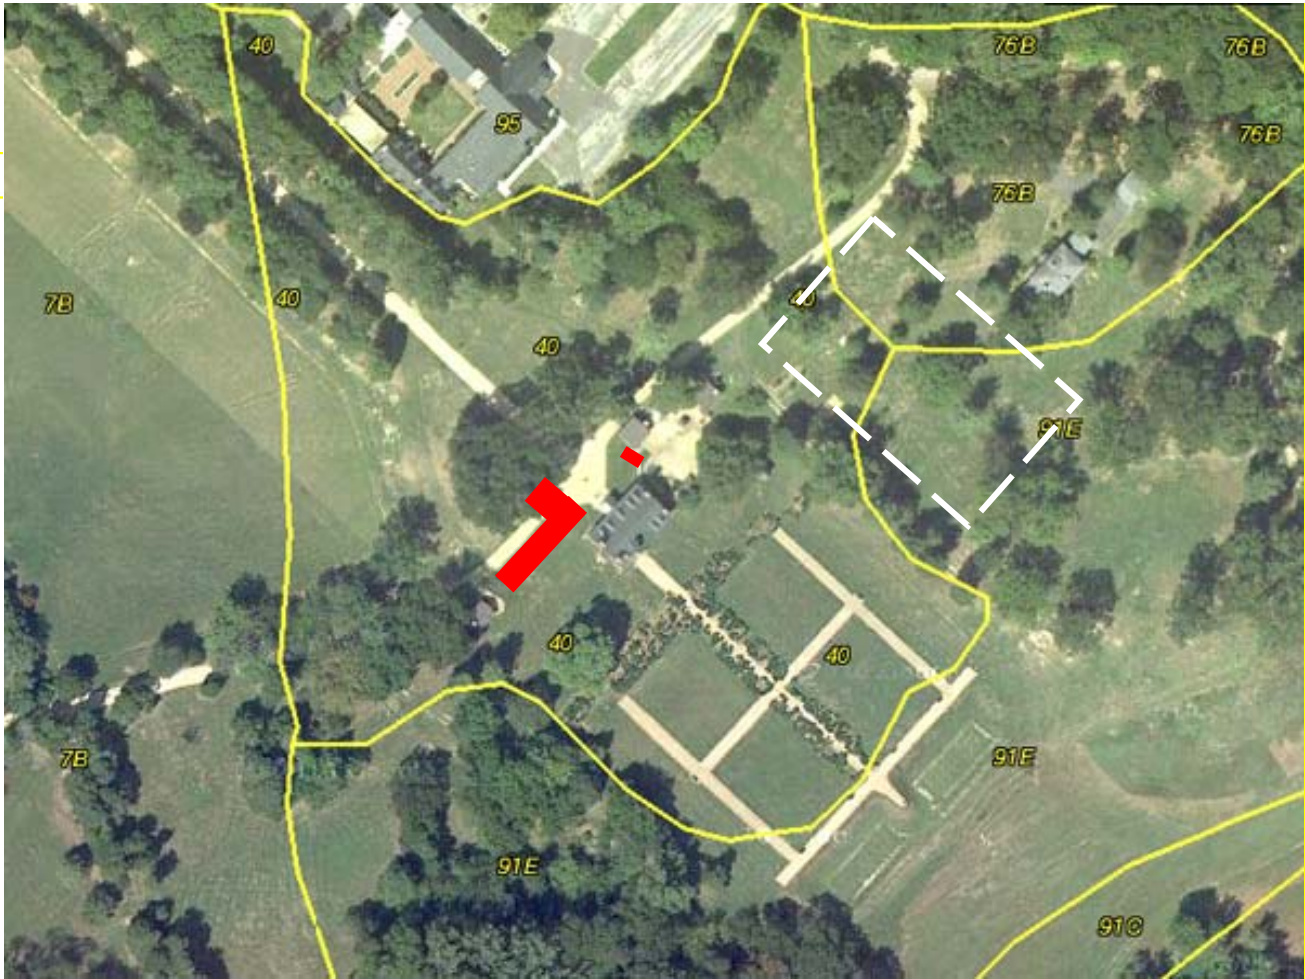
**Figure 2.** The soil series in the area investigated during 2011 is designated Grist Mill sandy loam (indicated as 40 in the map). Excavation work was done in the areas indicated in red. Soil phosphorus testing was done within area designated by white dashed lines. The surrounding soil series are: Beltsville silt loam (7B); Matapeake silt loam (76B); Sassafras-Marumsco complex with 7% to 15% slopes (91C); Sassafras-Marumsco complex with 25% to 45% slopes; Urban (95). (Detail from California Soil Resource Laboratory 2010).

The study areas were near the northwest face of the Gunston Hall mansion and in the kitchen yard associated with the mansion. The mansion is near the east end of a ridge that runs in a more-or-less east-west direction across the Mason Neck peninsula (Fig 1.). The landscape is generally flat and open, with a scattering of trees and buildings. The soil in the area excavated was of the relatively well-drained Grist Mill sandy loam series (Fig. 2).

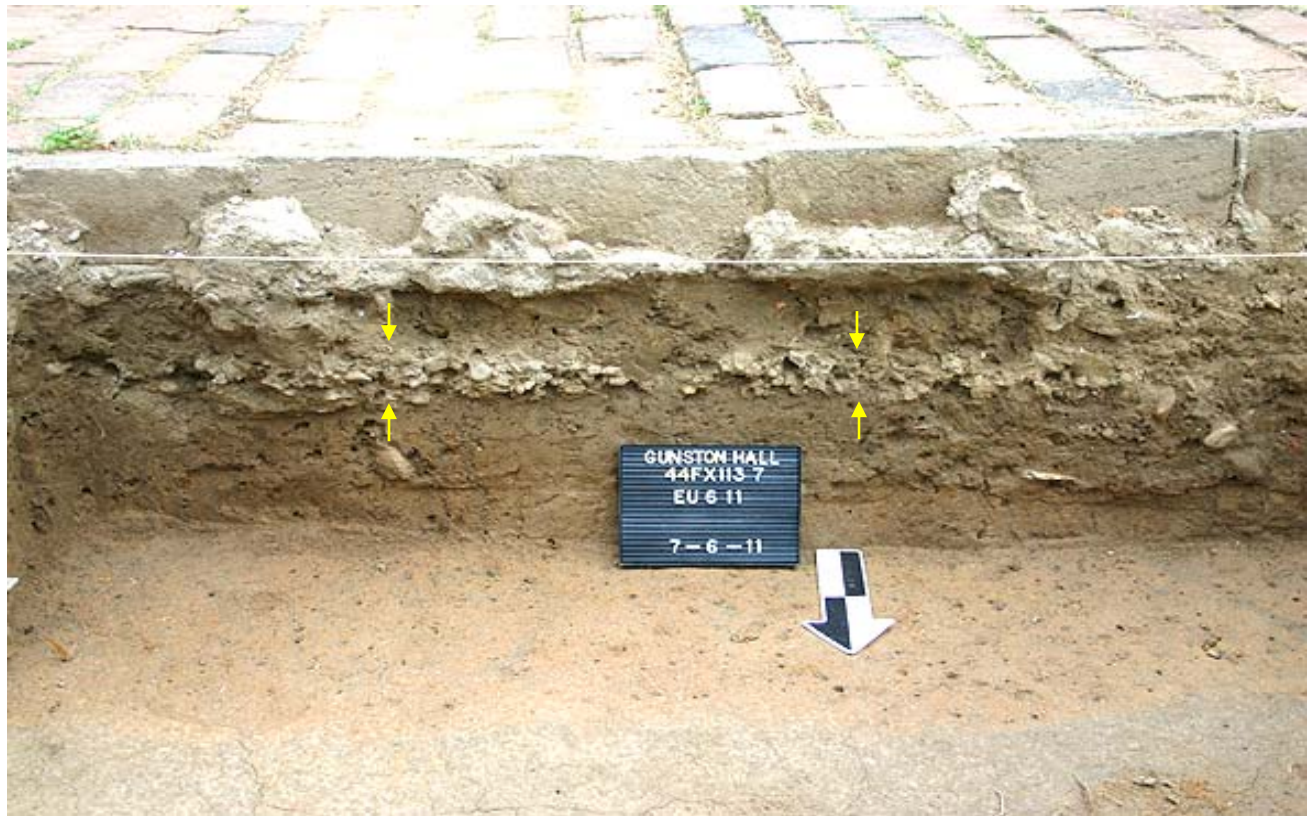
**Figure 4.** A section of the eighteenth century pebble walkway (yellow arrows) lying under a modern brick walk. This is feature F1-11 as seen in the south sidewall of unit 6-11.

Feature F1-11 was directly in line with the previously found walkway feature, F1-10. However, it was not initially known whether the presumed walkway would have continued along this line or made a right turn to pass along the south side the kitchen structure. For this reason, units were placed in both directions. Units 3-11, 5-11, 7-11 and 9-11 (Fig 3.) were all too badly disturbed to make a determination as to whether or not a walkway once passed through them.

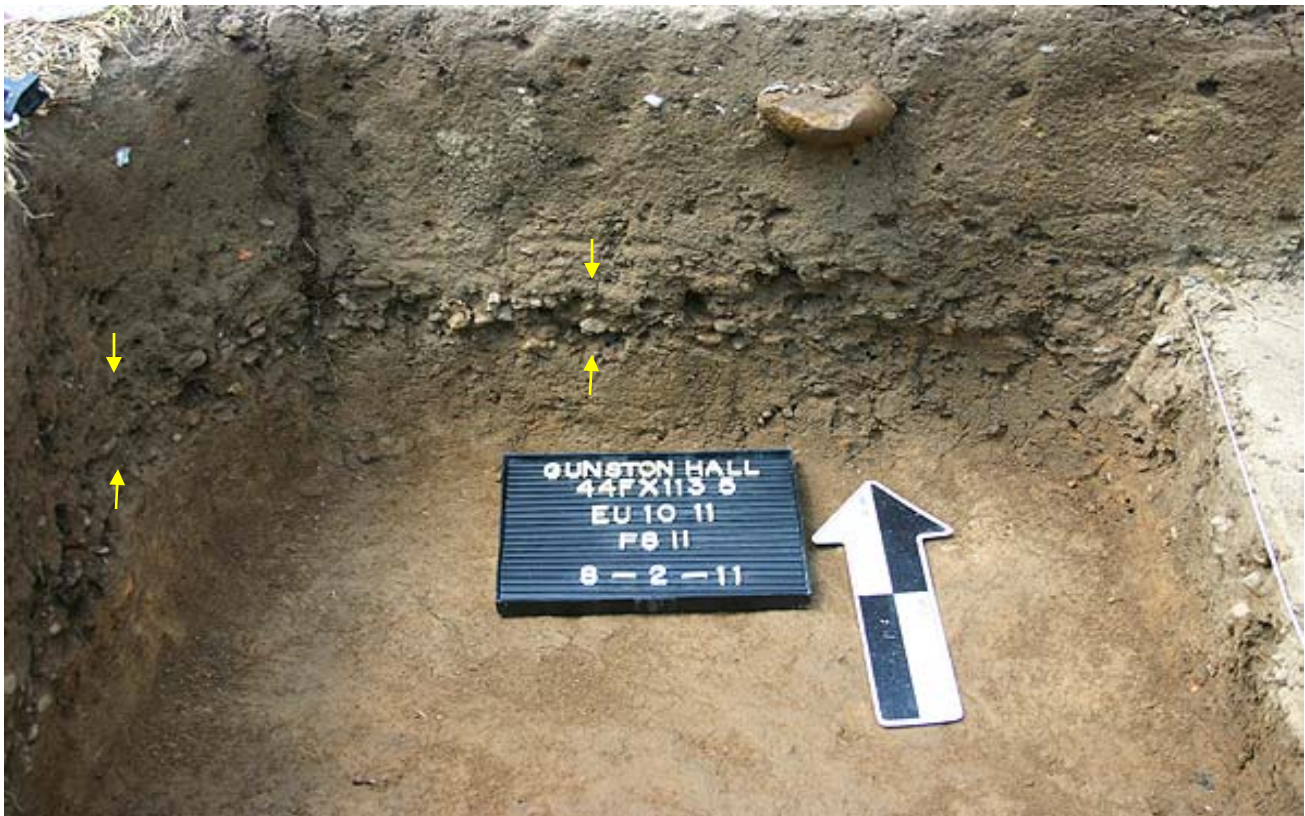
**Figure 5.** The pebble walkway feature F11-11 (yellow arrows) is seen extending into the sidewalls of unit 10-11, which is here in the process of being excavated. (The photo board says “F8-11.” The feature was later redesignated “F11-11” to make it consistent with a continuation of the feature in the adjacent unit, 12-11.)

The segments of the feature thus far uncovered indicate that this part of the original walkway trended in a north-south direction. The part of the walkway that lay immediately to the south of unit 14-10 was destroyed by the old cellar. It may have continued south beyond the cellar, but it is more likely to have turned toward the current basement entrance of the mansion (which is thought to have been Mason’s basement entrance as well). Another fragment of the walkway may have been detected with a soil probe just to the north of unit 12-11. This feature stops just about at the midpoint of the west wall of the kitchen structure. If the feature is indeed part of the walkway, and it does truly terminate where the probe seems to indicate, then it is possible that the walk lead to a doorway midway along the west side of the structure that rested on the old foundation. This supposition will need to be tested with future excavations.

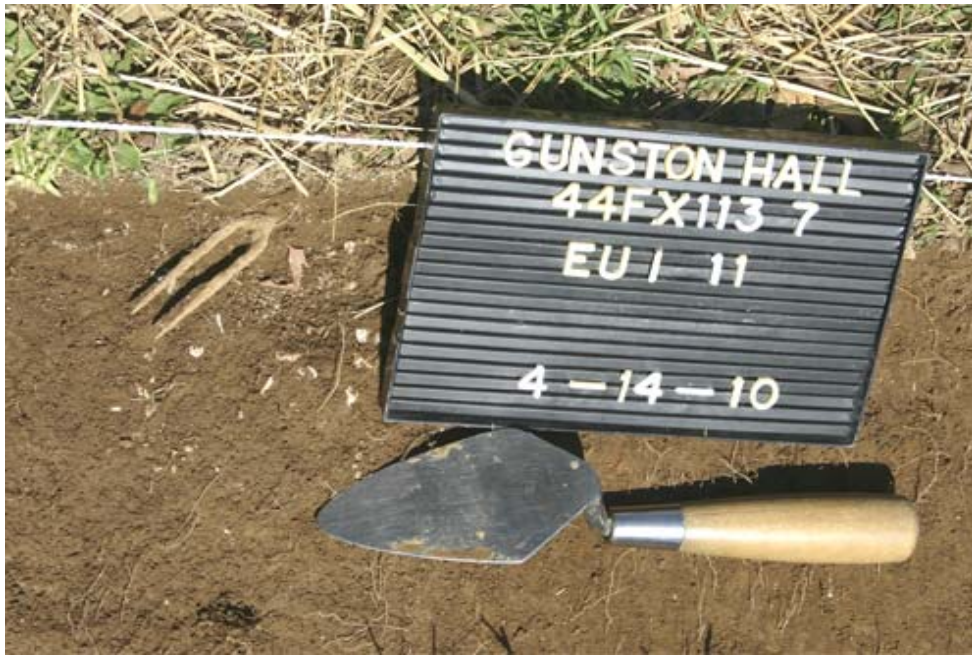
**Figure 6.** A two-tined fork emerges a very short distance from the soil surface.

That is why a fork which appeared about one inch below the surface (Fig. 6) in excavation unit 1-11 was greeted with both surprise and a certain amount of skepticism. The skepticism was engendered both by the good state of preservation and the high level in the soil in which the artifact rested. It had two pointed tines, which were circular in cross section. The body was

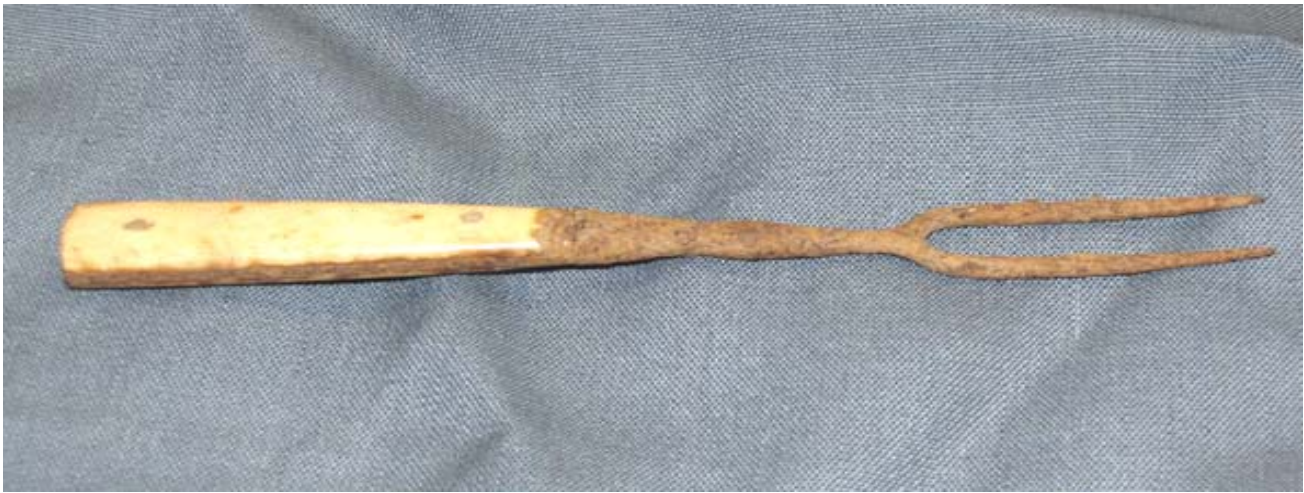
**Figure 7.** Fork prior to conservation. (Photo by Susan Blankenship.)

ferrous, probably steel, and exhibited a moderate amount of corrosion. The handle was made of bone, or possibly antler. Two pins, which appeared to be of some sort of white metal, secured the handles to the body of the fork (Fig. 7).

The fork is corroded from burial. The iron portions are covered with a thin layer of voluminous corrosion products which include soil deposits. There are a few small cracks in the top surface of the iron on the prongs of the fork. The iron is actively flaking. In areas where flakes of iron have become detached small spots of bright orange corrosion are visible. This corrosion is an active chloride based corrosion product called alkageneite. Alkageneite is damaging to the iron as it forms a tubular structure that actively pushes the iron apart. The iron has a strong magnetic pull, which indicates the iron has a solid metal core and that the core metal is not heavily corroded. Edges of the bone that are in direct contact with the iron are stained orange from iron corrosion products. The bone on the back of the fork is stained from the soil and/or use and contains faint scratches. There are tiny losses of bone around the rivets. These losses may have occurred when the rivets were inserted. (Norquest 2011)

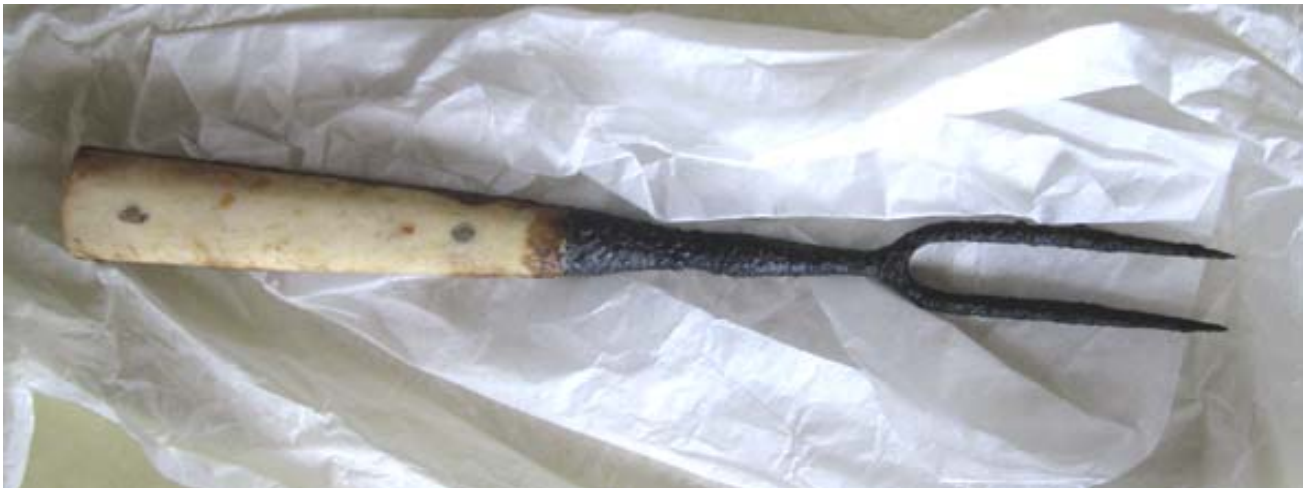
**Figure 8.** Fork after conservation. (Photo by Caroline Riley.)

The ferrous portions of the fork were cleaned of corrosion products by air abrasion using alumina powder. The treated surface was then coated with a microcrystalline wax to retard the reoccurrence of corrosion. Dry brushing, followed by swabbing with distilled water, was used to clean the bone handle. (Norquest 2011)

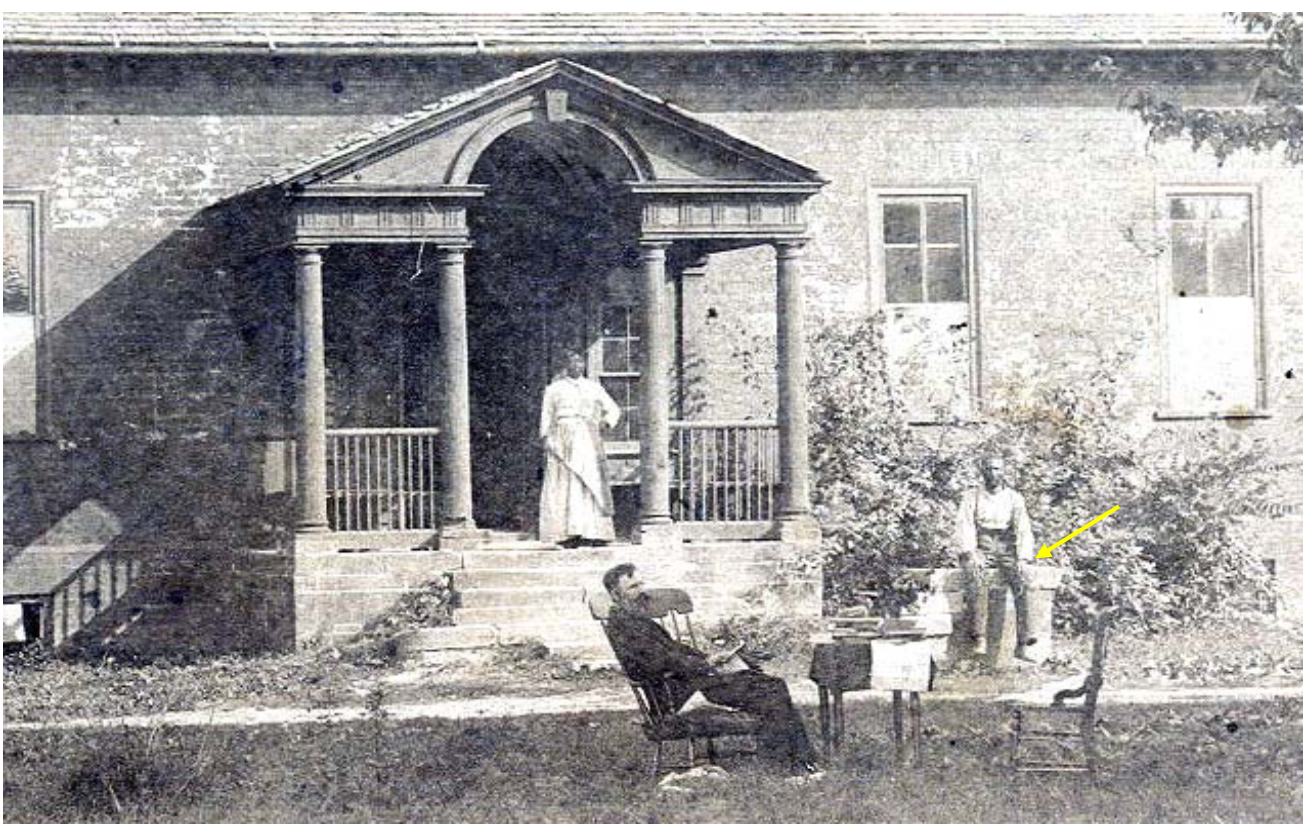
**Figure 12.** This c.1880 photo was the primary one used in the initial attempt to pinpoint the location of the land front carriage mounting block (arrow). Col Edward Daniels, then the owner of Gunston Hall, is seated in the foreground. (Detail of photo from the Gunston Hall archive.)

Several nineteenth century photographs were used in the effort to estimate the location of the mounting block. However, the principal one used is that shown as Figure 12. Recently, a more revealing photo has surfaced (Figure 13). This photograph was made sometime during the period 1892-1898, when Joseph and Emma Specht owned Gunston Hall. Here, the mounting block appears closer to the central axis of the mansion and further from the portico than in Fig. 12.

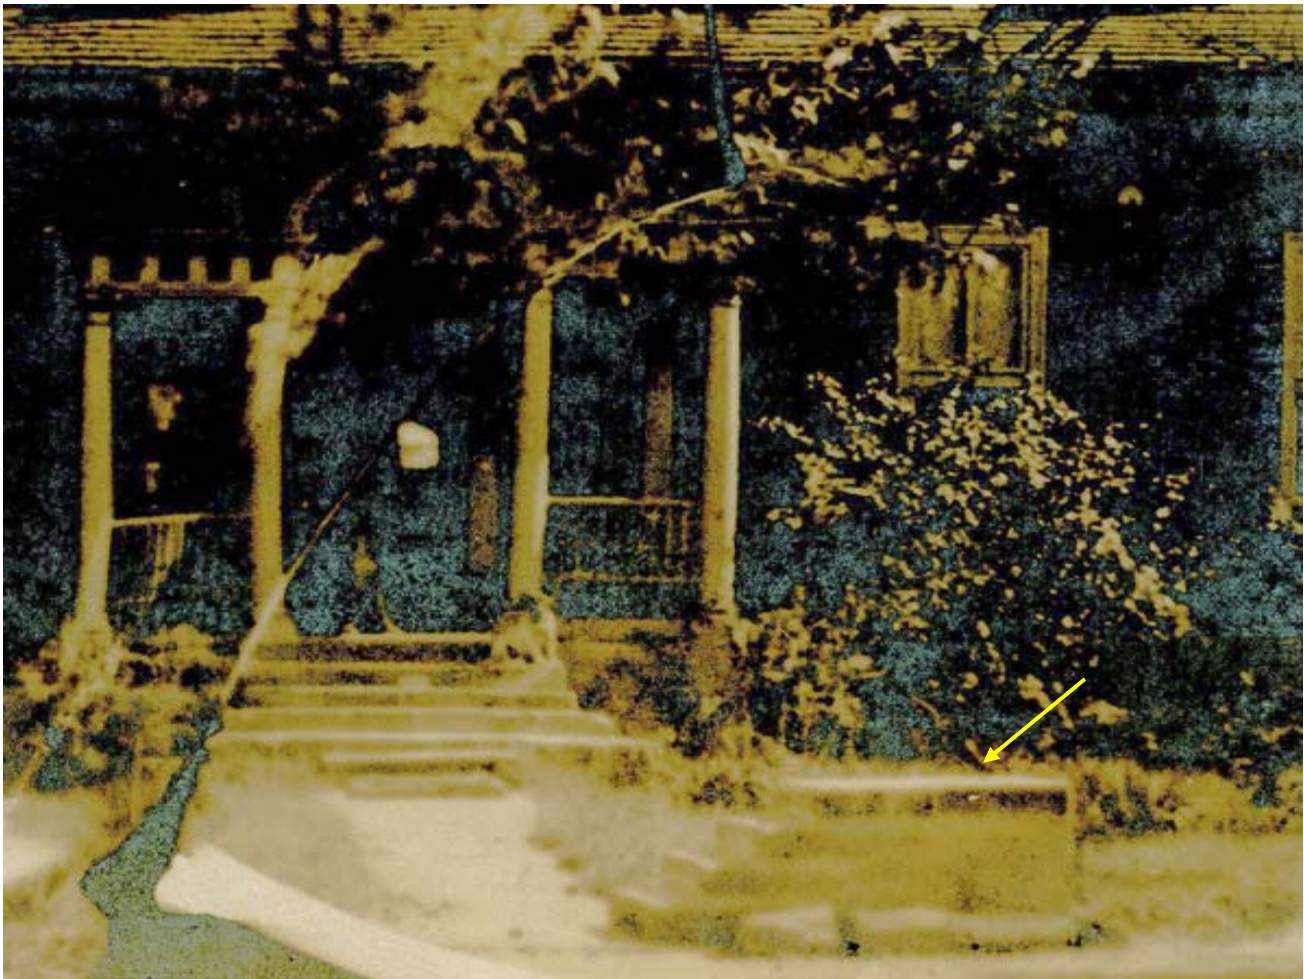
**Figure 13.** A photo taken sometime in the period 1892 – 1898 gives a better idea of the location of the carriage mounting block. (Detail of photo from the Gunston Hall archive.)

First priority will be given to investigating the possibility that Feature F14-11 might represent part of a carriage circle. Initially, units will be excavated immediately to the east and north of unit 16-11. If these show promise, additional units will be excavated in order to determine the shape of the feature so that it can be replicated. In addition, the photograph reproduced here as Fig. 13 will be used as the basis for another attempt to find the footprint of the carriage mounting block.

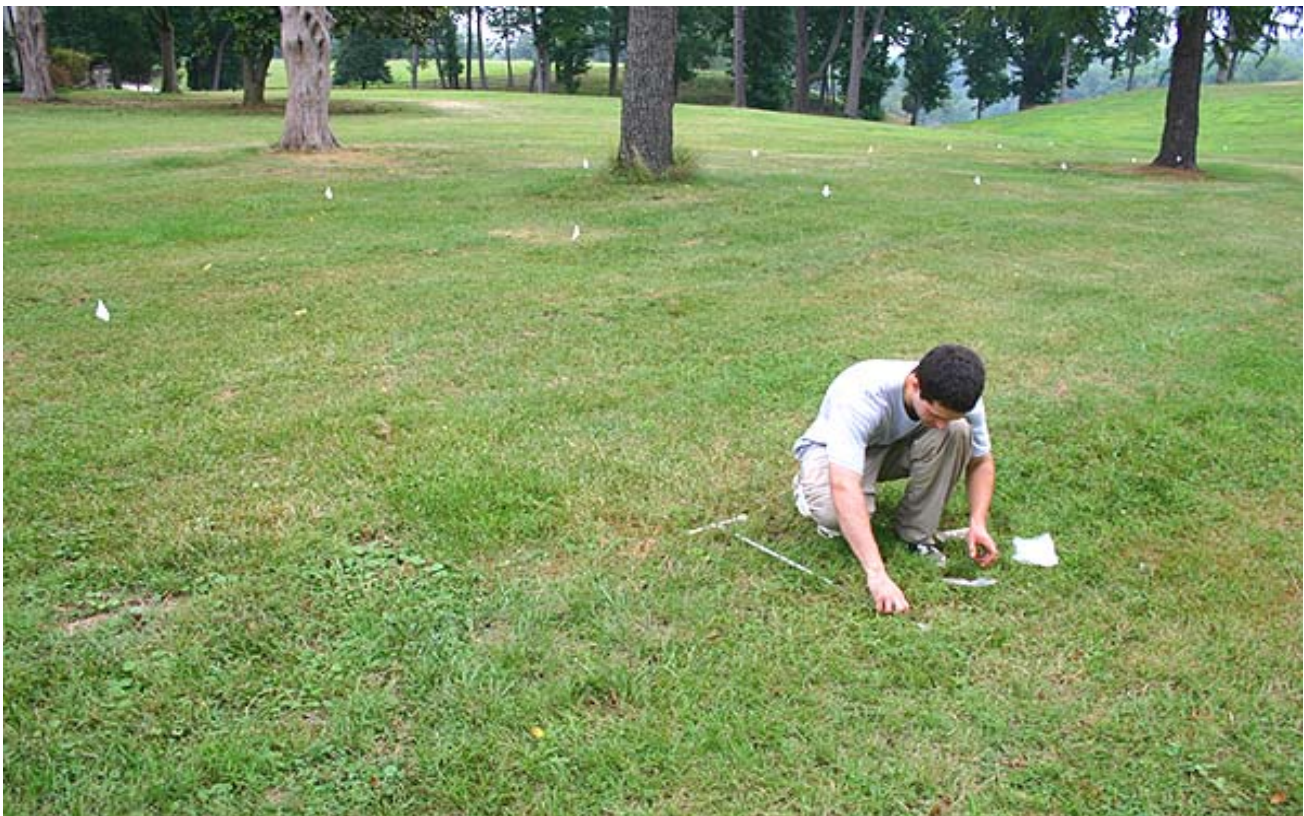
**Figure 14.** Soil samples were collected for analysis at ten-foot intervals on a 2,000 sq.ft. area between the mansion and garden area and the Director’s Residence.

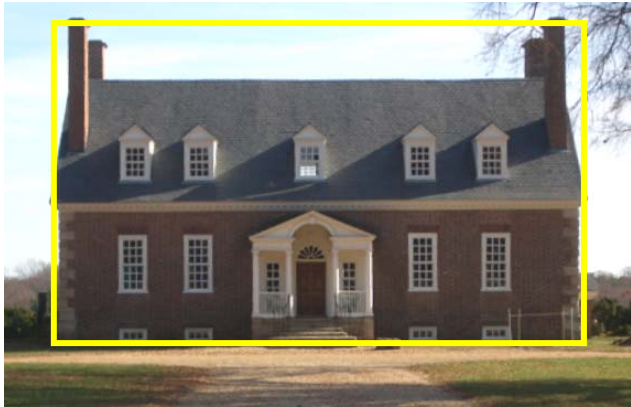
Figure 5 Gunston Hall with Golden Rectangle, picture by W. Miervaldis

mansion, including the quoins, is slightly less than 61 feet, whereas the length of the eaves is slightly more than 61 feet. The proportion of 61 feet in length to a height of 38 feet closely approximates the Golden Ratio of 1.618. (Figure 5) Furthermore, the location of the landside

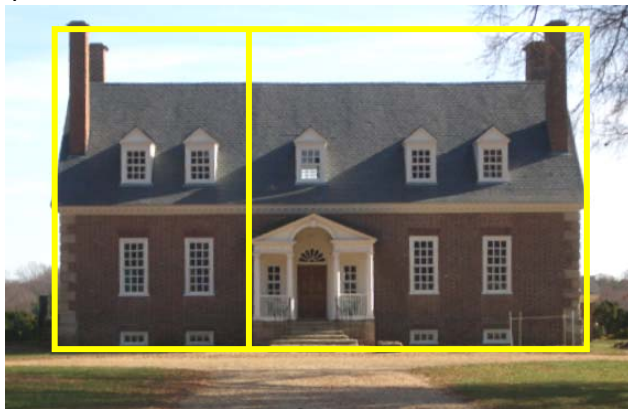
Figure 6 Gunston Hall with Golden Rectangle (2), picture by W. Miervaldis

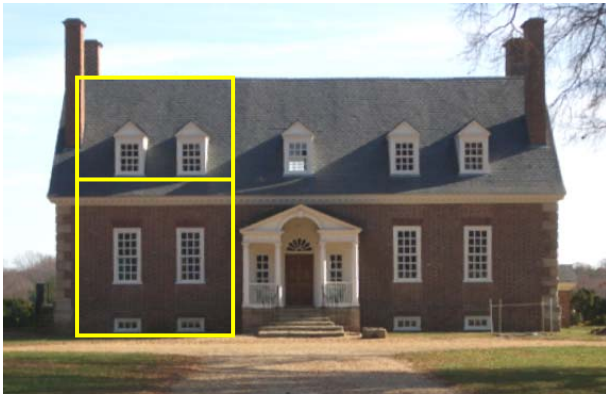
Figure 7 Gunston Hall with Golden Rectangle (3) picture by W. Miervaldis

close to approximating a Golden Rectangle. Within this rectangle, the bottom panes of glass in the dormer windows are placed at approximately 13 feet from the top of the roofline. Once again, this separates the rectangle into two smaller rectangles whose lengths are also in the golden ratio with each other. Two other observations should be made at this point. Golden rectangles are also formed if this rectangle is separated at the top of the lintels on the first floor windows. Secondly, the eaves occur halfway between the roof top and the ground or approximately 16.5 feet up from the ground. Perhaps it is coincidental that the measure of a

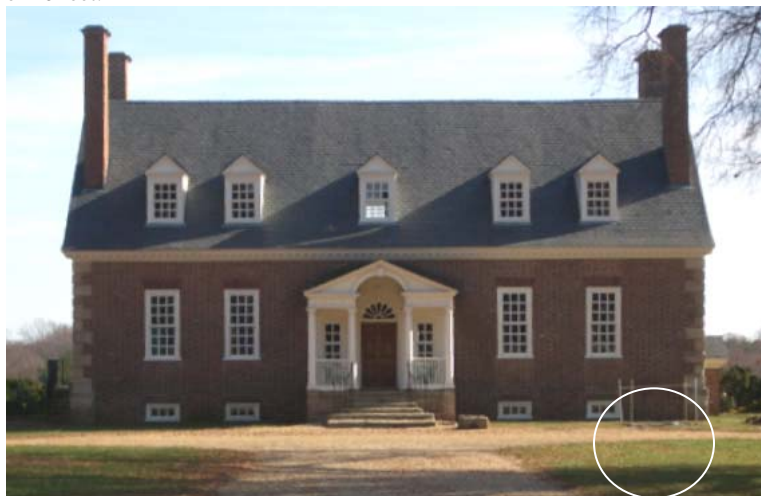
Figure 11 Excavation unit shown to right of portico, picture by W. Miervaldis

doorway of the mansion toward where the cherry trees would have begun but again, no evidence of 18<sup>th</sup> century artifacts or gravel was found. Two volunteers, one of whom was Claudia Wendling, used a metal rod to test for changes in the consistency of the soil and found that some type of change seemed to be occurring in the soil at a distance of around 240 feet from the mansion. This was surprising in that John Mason's memoirs had stated that the cherry trees started at a distance of about 200 feet. This might indicate that the roadway could be closer to 240 feet away from the mansion. This find would also be somewhat consistent with the placement of the cherry trees in Morley Williams' plan from 1931. Further investigation is warranted.
