253)
Archeological Investigations at the Lexington Plantation Site,
 44FX736

Mason Neck State Park
 Commonwealth of Virginia
 Fairfax County, Virginia

Fairfax County Park Authority
 Resource Management Division
 Cultural Resource Management and Protection Section
 2855 Annandale Road
 Falls Church, Virginia
 2008

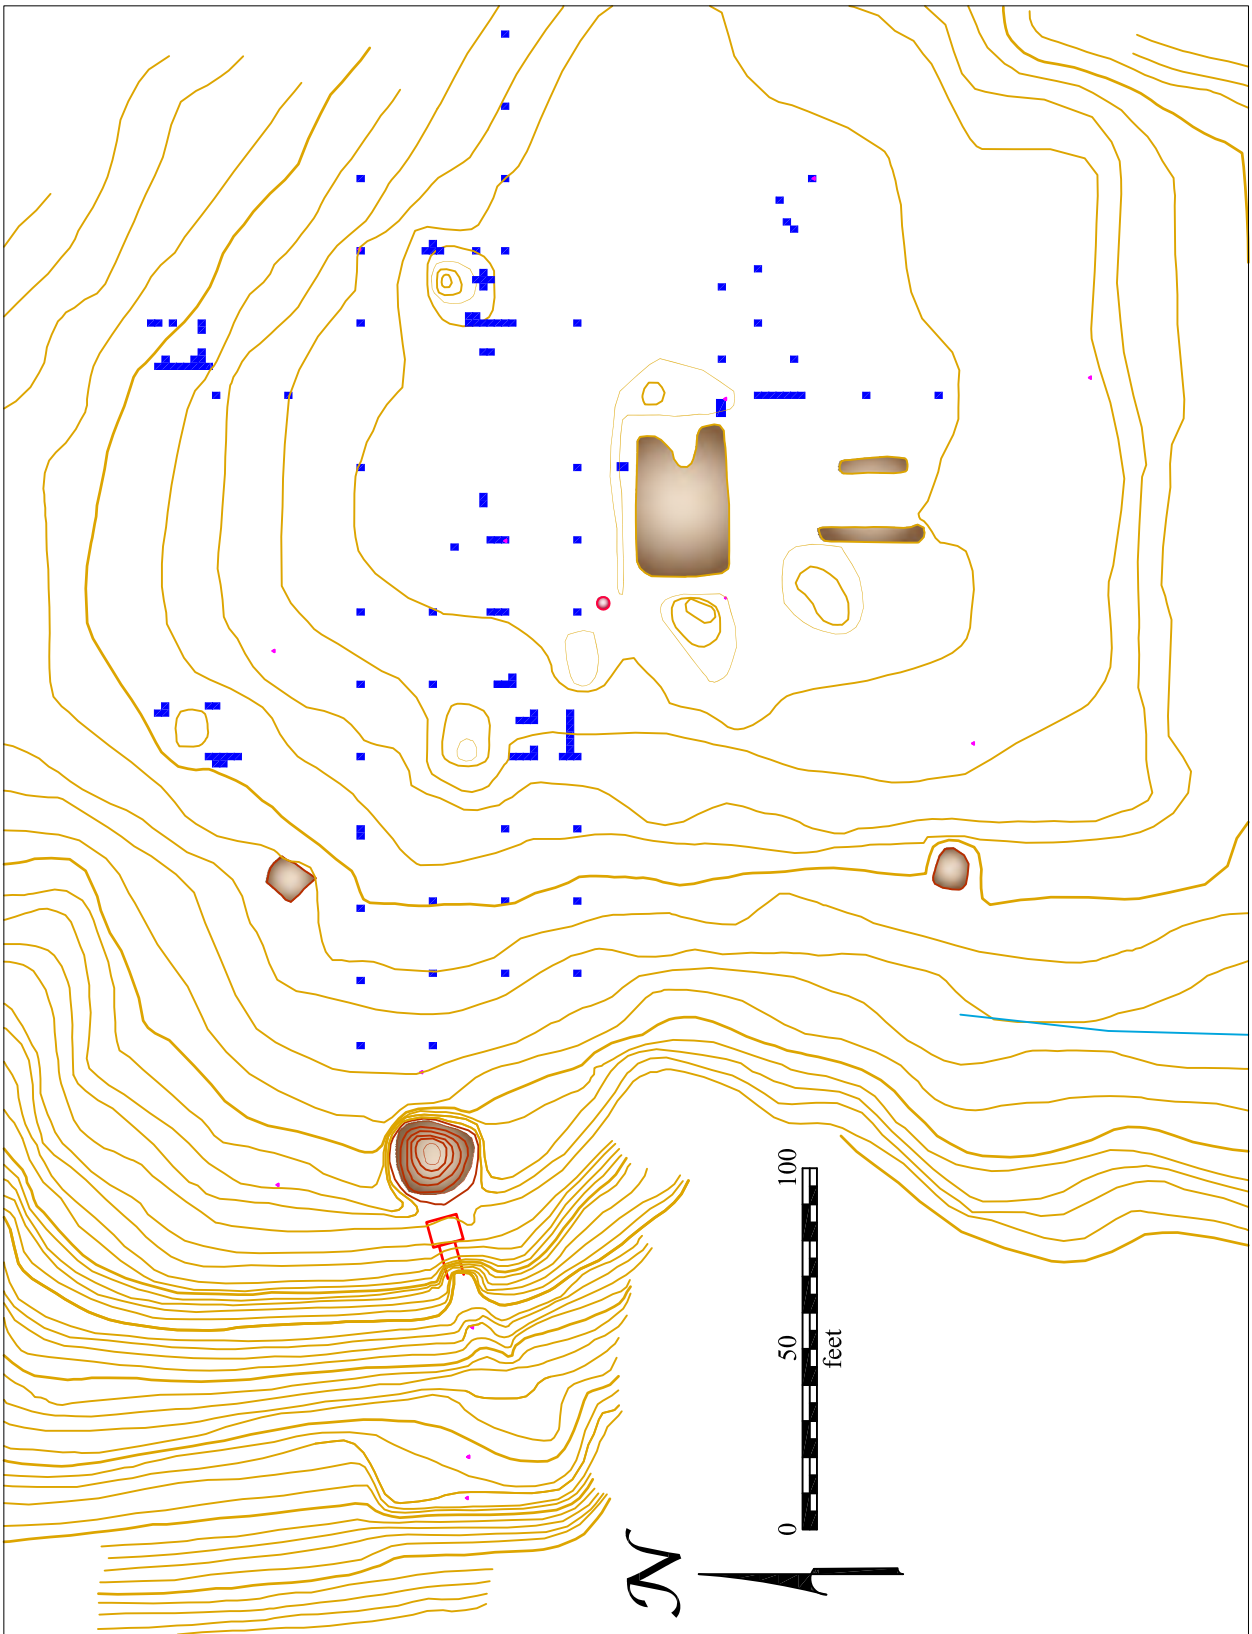
Figure 3.3. Archeological site plan.

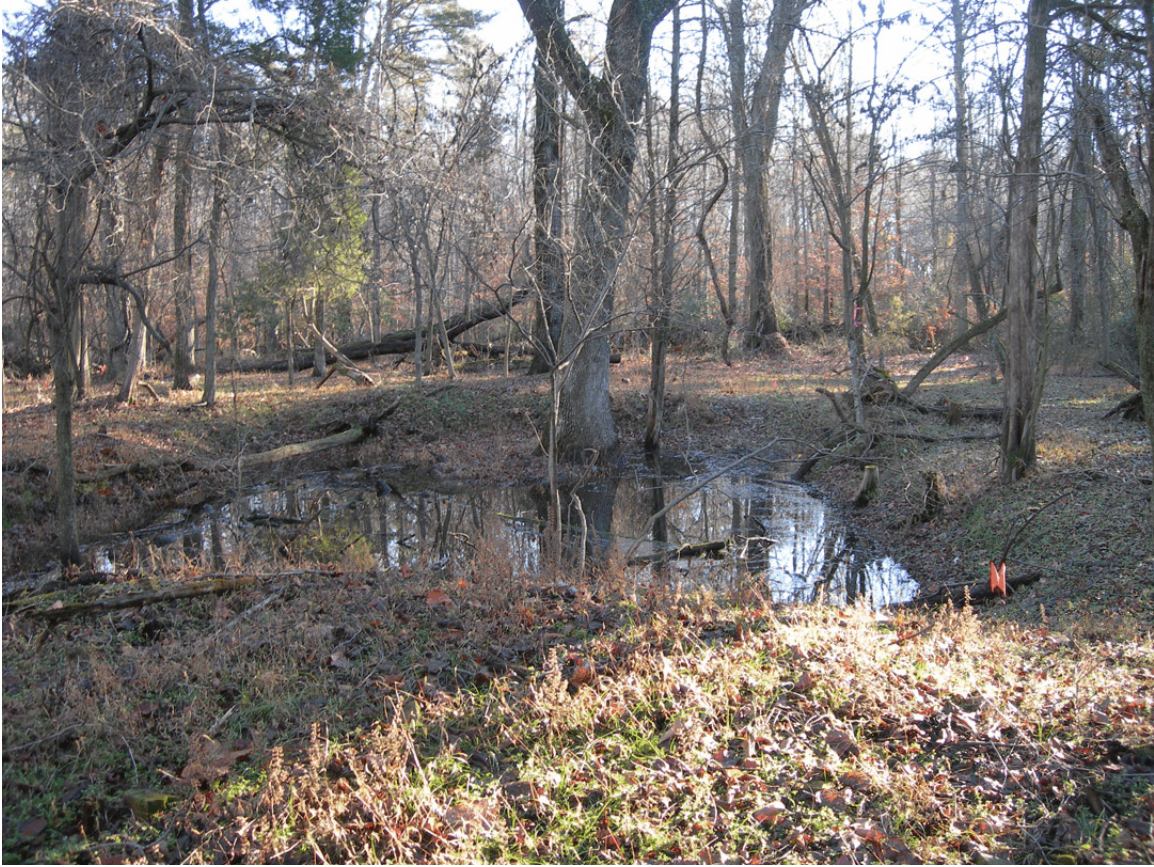
Figure 4.3. The main house cellar, facing east. The survey flags near the south corners of the cellar mark the location of the initial archeological base line.

The absence of a builder's trench indicates that the cellar hole was excavated to the dimensions of the cellar and that those walls were laid up from the inside of the cellar hole directly against the exposed earth. Most likely, given the relatively shallow depth of the cellar, the hole was dug entirely by hand. It is possible given the nature of the soils that the excavated materials were fired at some location on site to make the

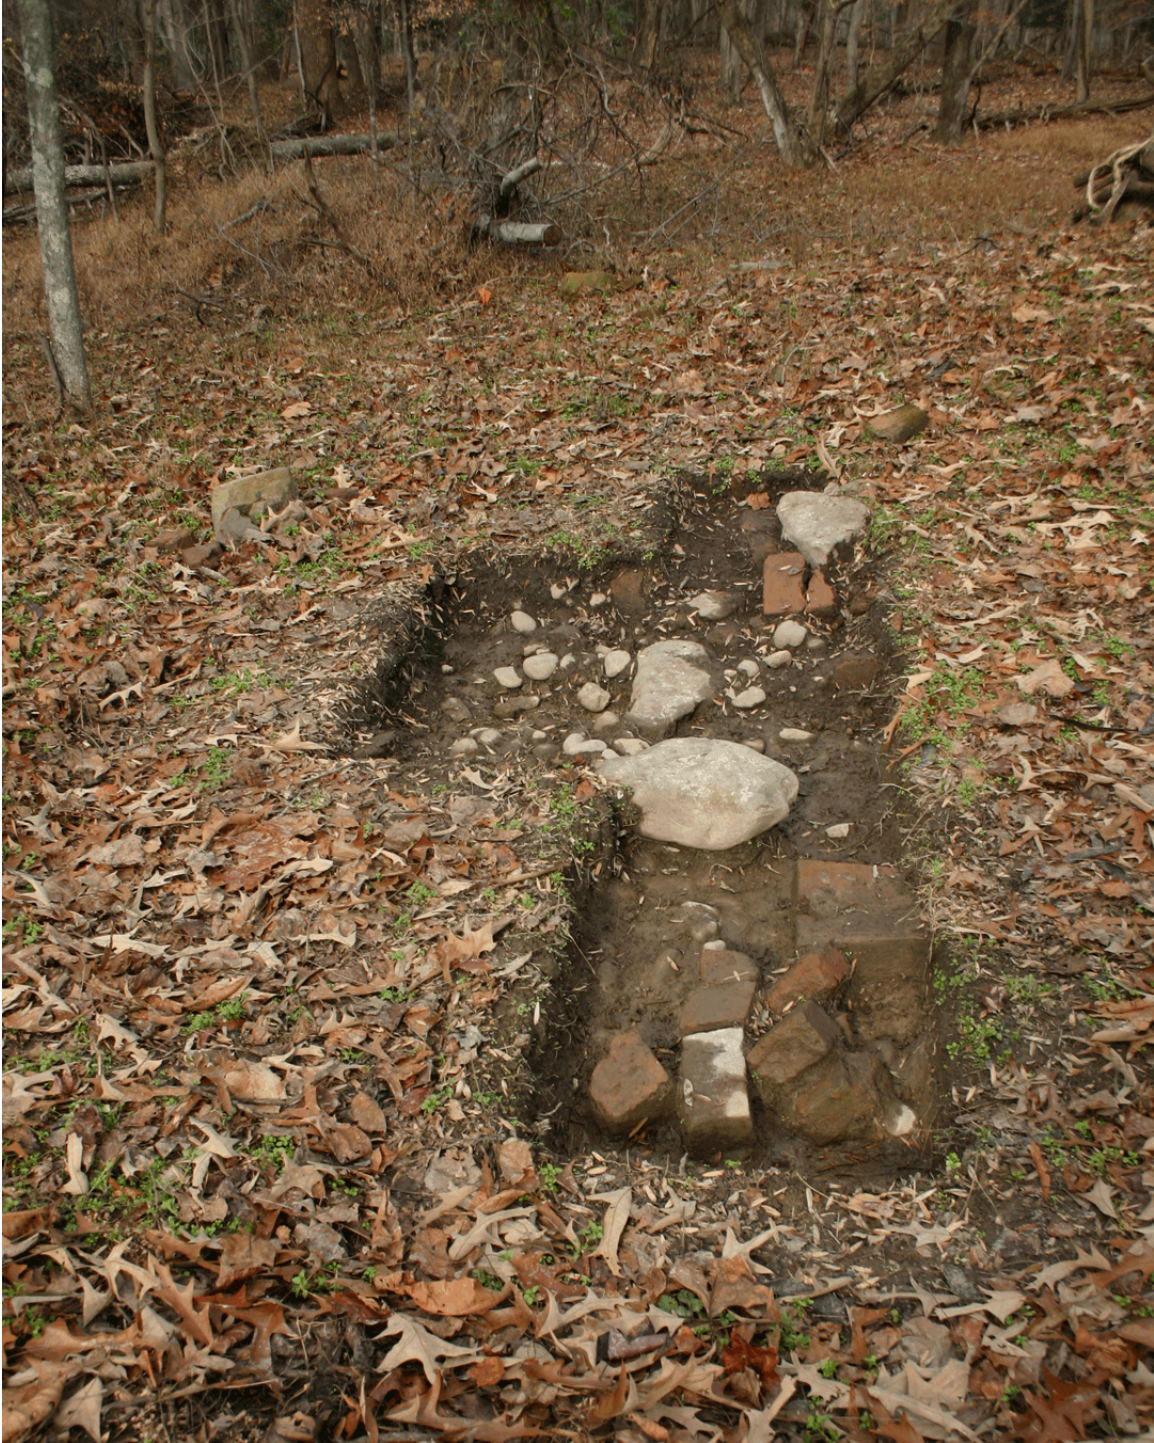
Figure 4.19. The southwest corner of Structure 2W, facing north.

A single test unit was excavated initially near the southwest corner of the rubble mound (Figures 4.18 and 4.19). This unit was then expanded to a contiguous block of seven test units until the foundation corner was located and the associated cobble paving which had been discovered could be partially exposed and studied. The southern two units (N1134E900 and N1136E900) contained a section of brickwork which was

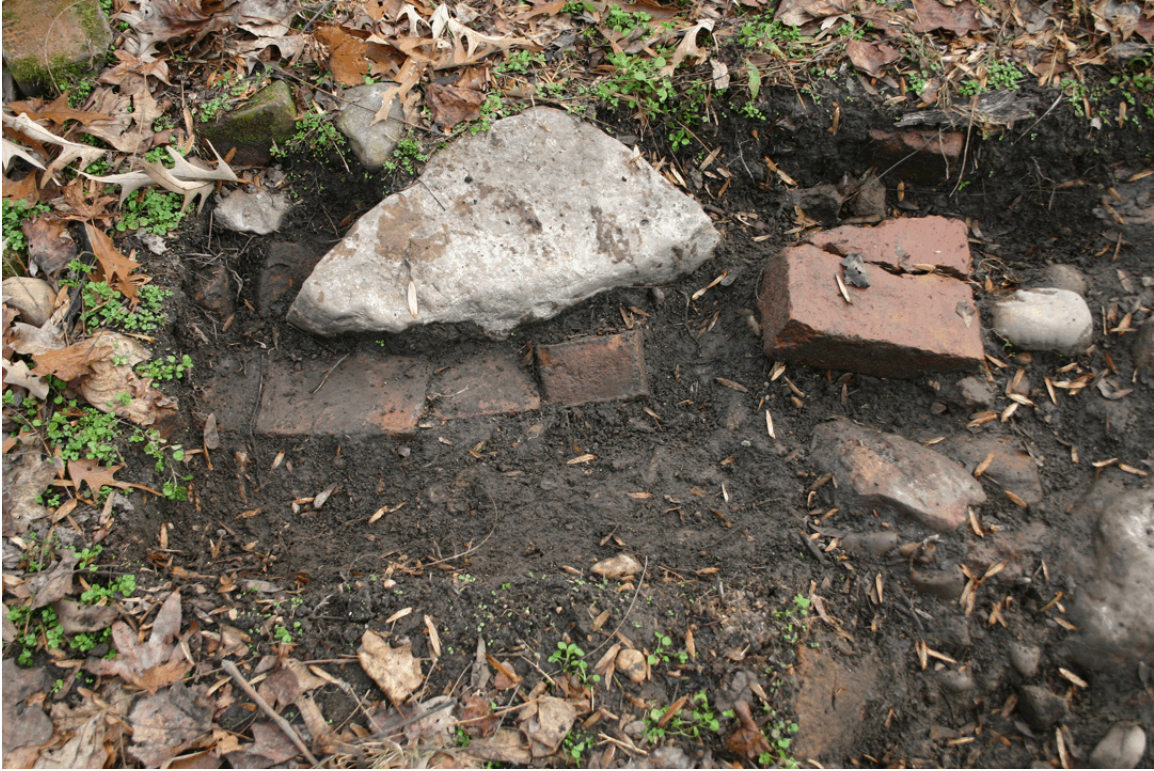
Figure 4.20. Detail of the southwest corner of Structure 2W, top faces east.

assumed to have been displaced from the foundation. Three boulder-sized, relatively flat rocks of historically transported origin, but of unknown function, were found lying within the four northern test units along the east side of the excavation block. To the south and continuing along the west side of the foundation, multiple “layers” of cobbles were found. Probing indicated that the cobbles extended further south past the

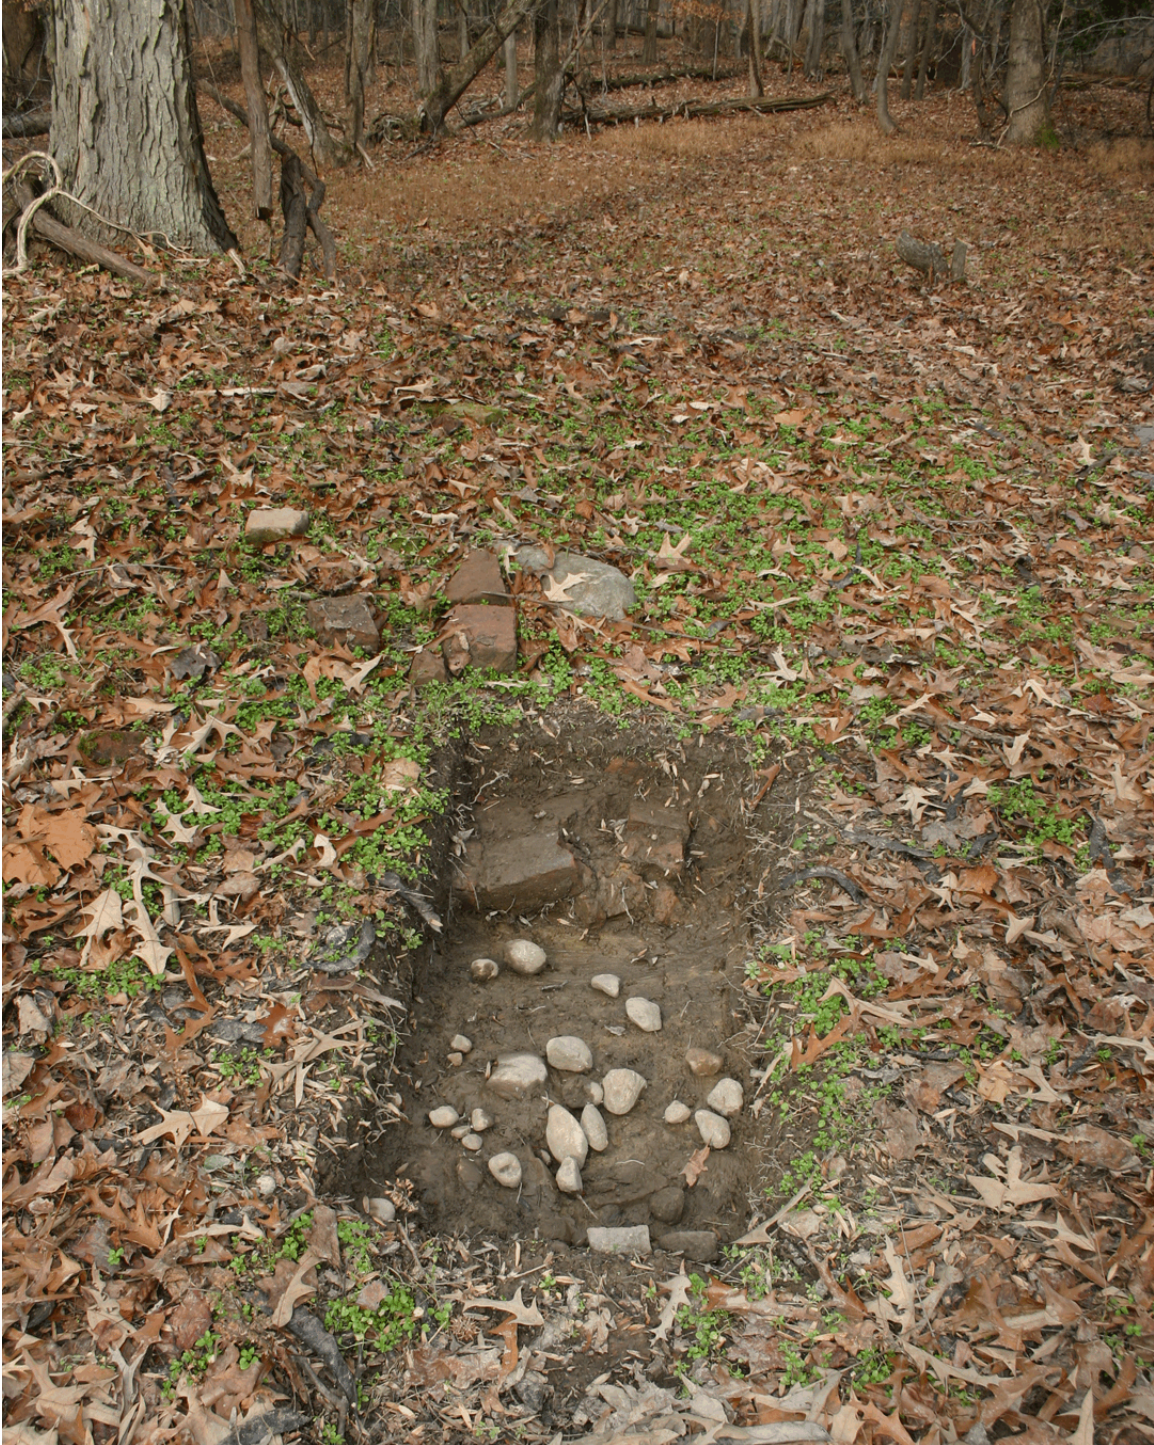
Figure 4.21. The southeast corner of Structure 2W, facing north.

Using on an estimated smokehouse dimension of 14 feet, a test unit was placed east of the southwest corner. The southeast corner was found at approximately that distance. The corner here was somewhat more disturbed, but still distinct (Figure 4.21). The top of the corner appeared to have been crushed, perhaps from vehicle movement over it. The cobble paving along its south side, similarly, was disturbed and thinned. No

oyster shell layer associated with the cobble paving occurred. The absence of staining in the subsoil adjoining the south side of the bricks indicates that a trench excavated to the width and depth of the foundation had been dug. Little extra digging, at least along the exterior, had been done. A large boulder-sized rock lay on the surface to its north, as did another fragment of square brick paving. The square paving

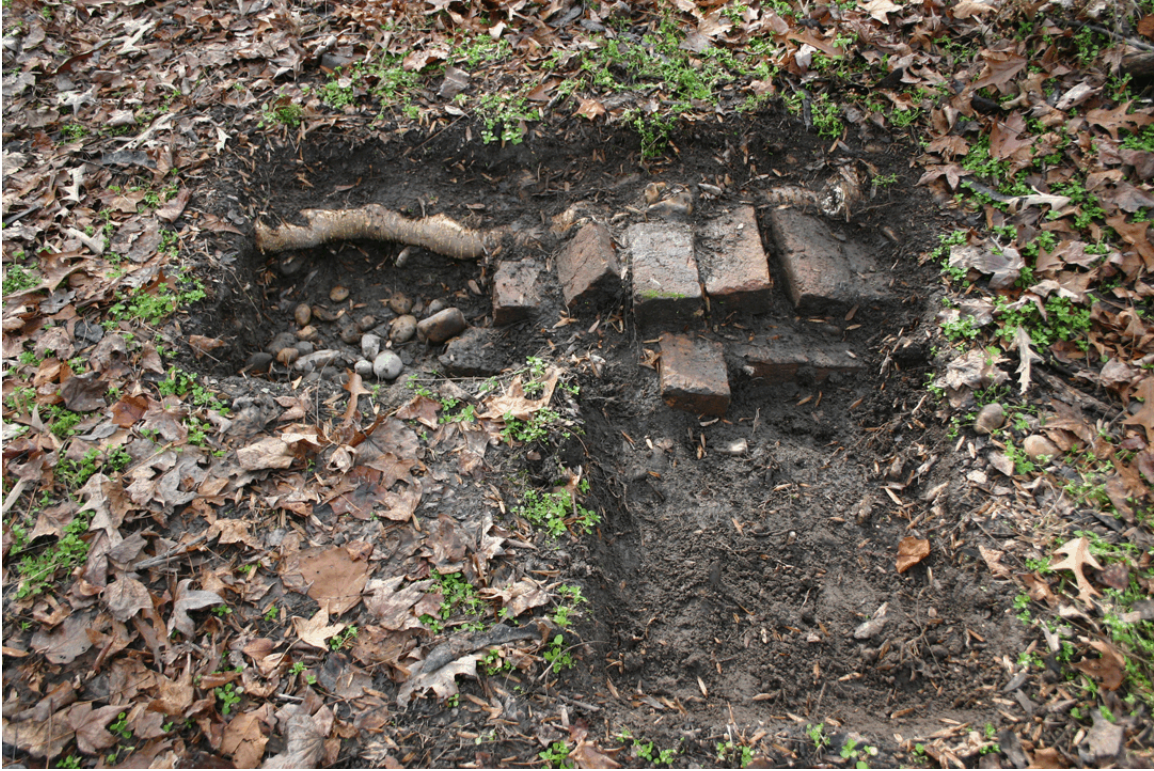
Figure 4.22. The northeast corner of Structure 2W, facing south.

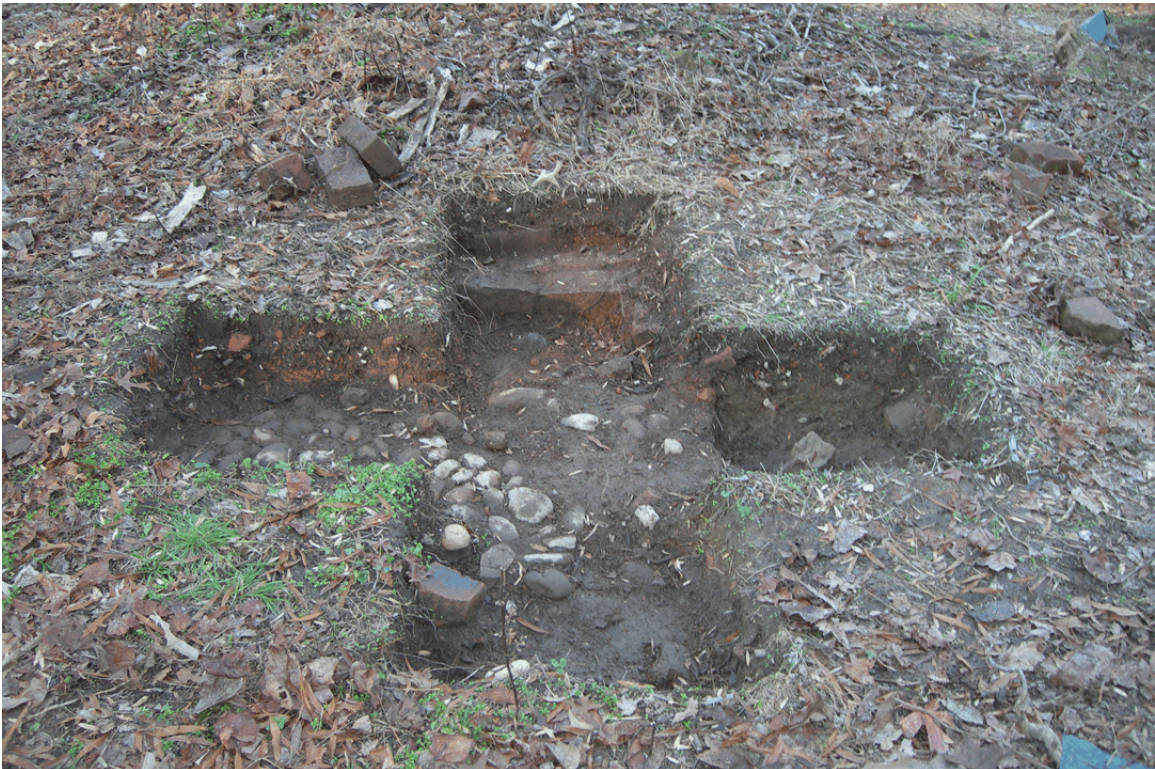
Figure 4.25. Structure 1E's south foundation wall and cobble walk, facing north.

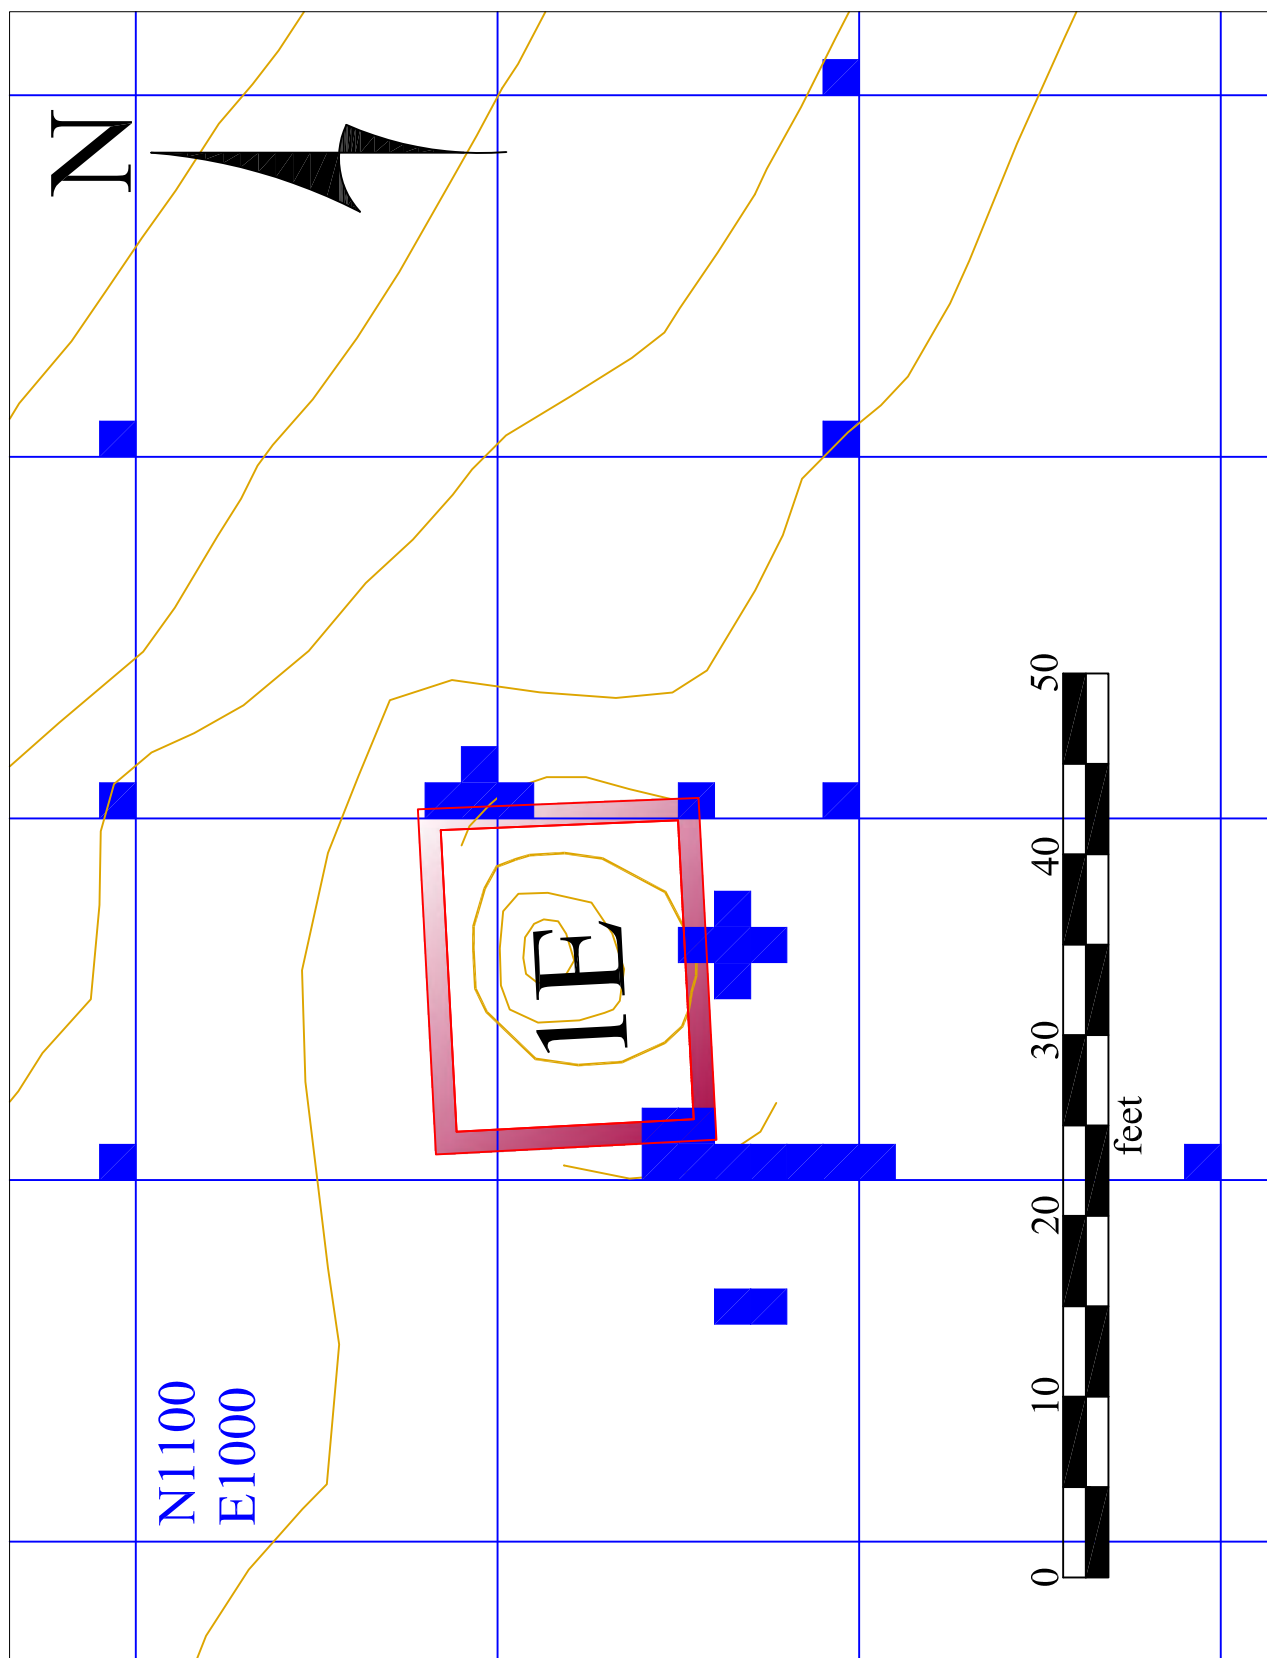
Figure 4.26. Archeological site plan for the Structure 1E area.

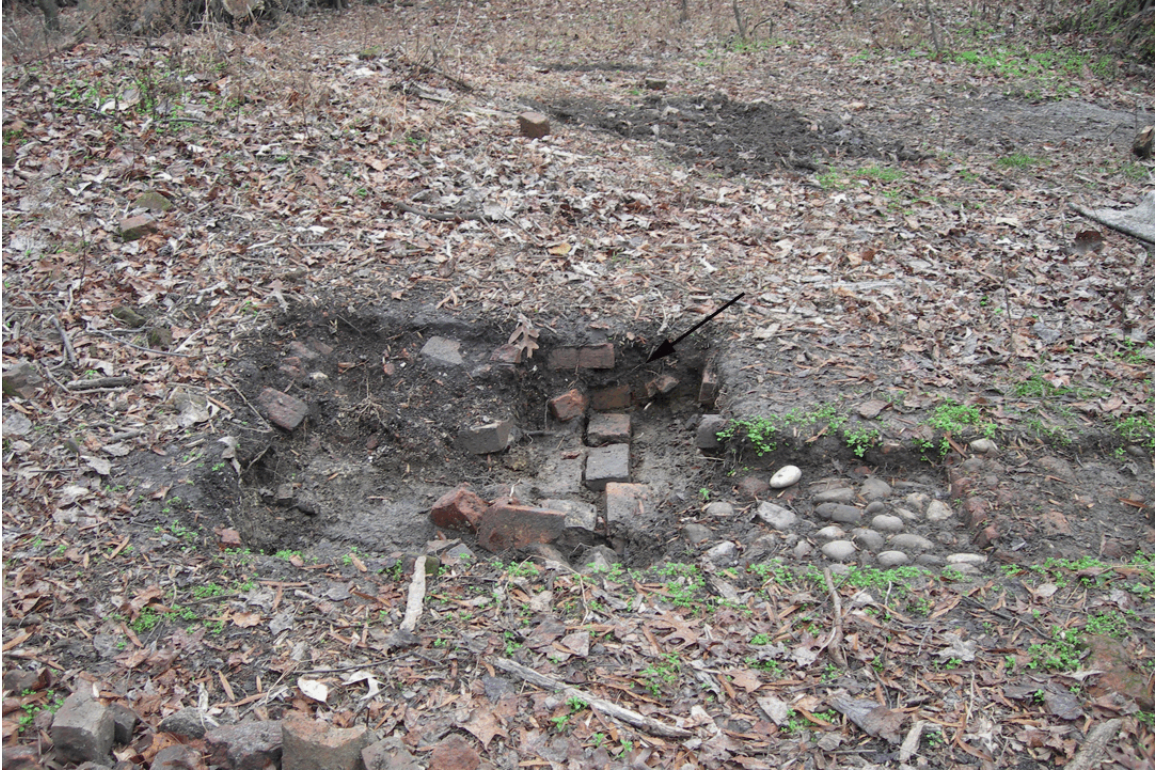
Figure 4.28. Southwest corner and south foundation wall of Structure 1E, facing east.

The southwest corner of the foundation was found within N1068E1022 (Figure 4.27). Only the lowest course of the foundation corner remained within this unit. This course rested within the top of the clayey subsoil. Considerable loose brick rubble and plaster fragments lay over the top of the bottom foundation course. The foundation was more intact along the east wall of this test unit, and three courses were evident in that profile (Figure 4.28). Undisturbed subsoil lay along the south and west sides of the corner. This

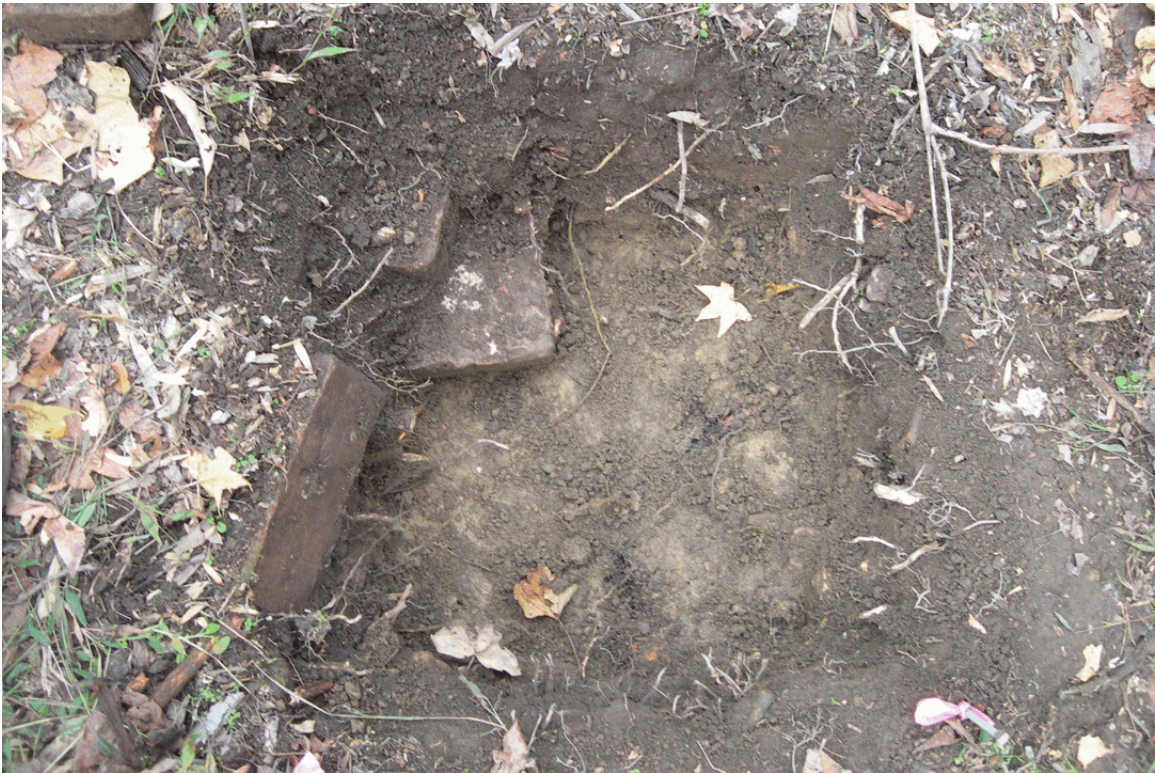
Figure 4.29. Structure 1E's southeast corner, top faces north.

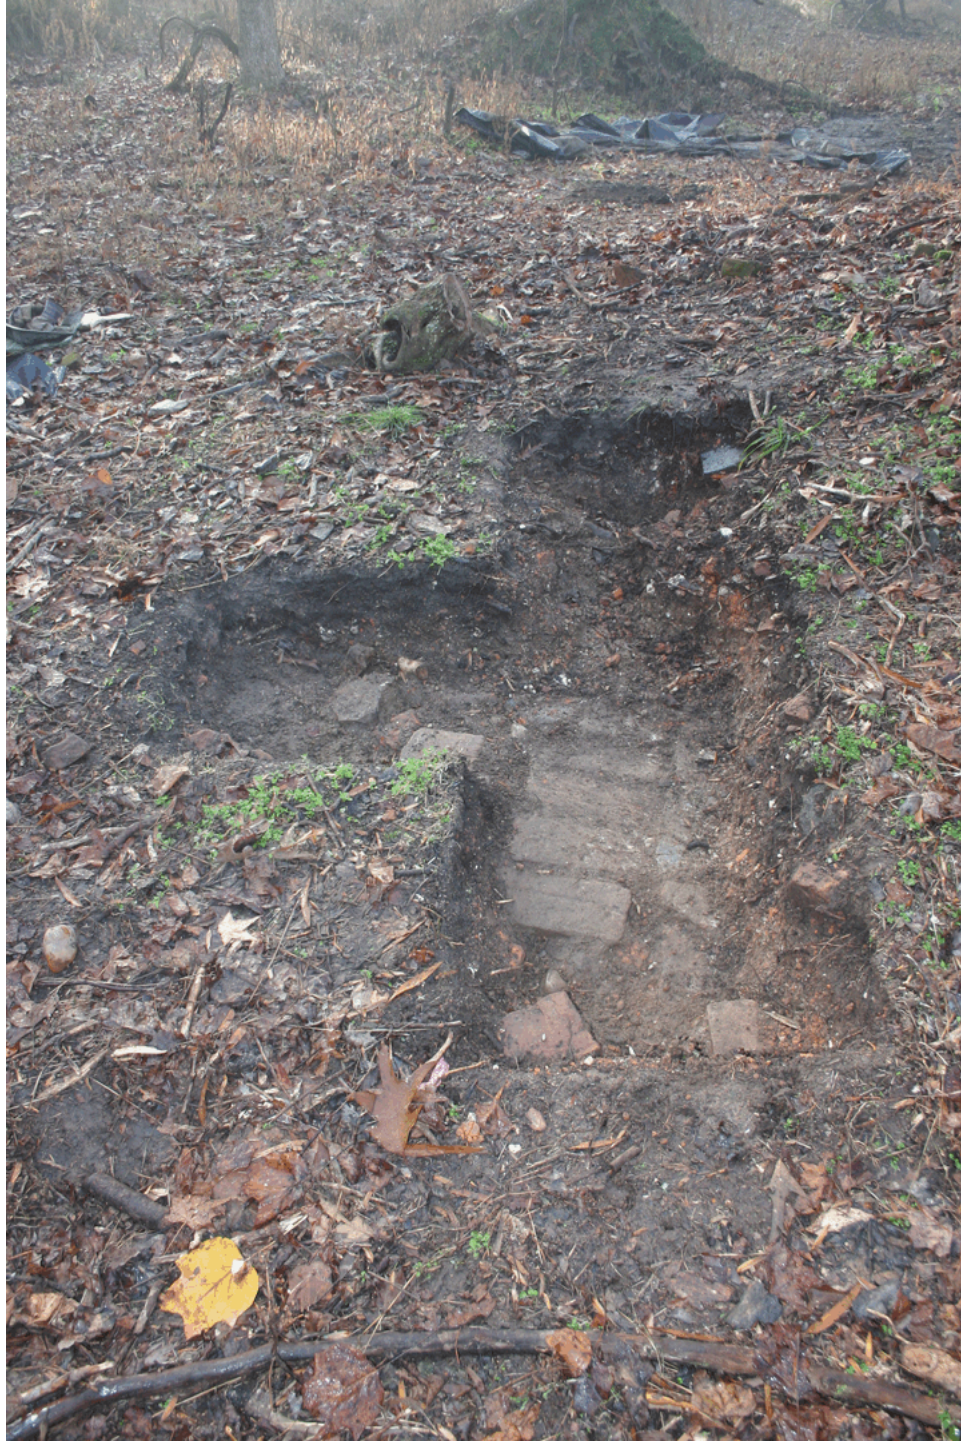
Figure 4.30. East foundation wall at or near the northeast corner of Structure 1E, facing south.

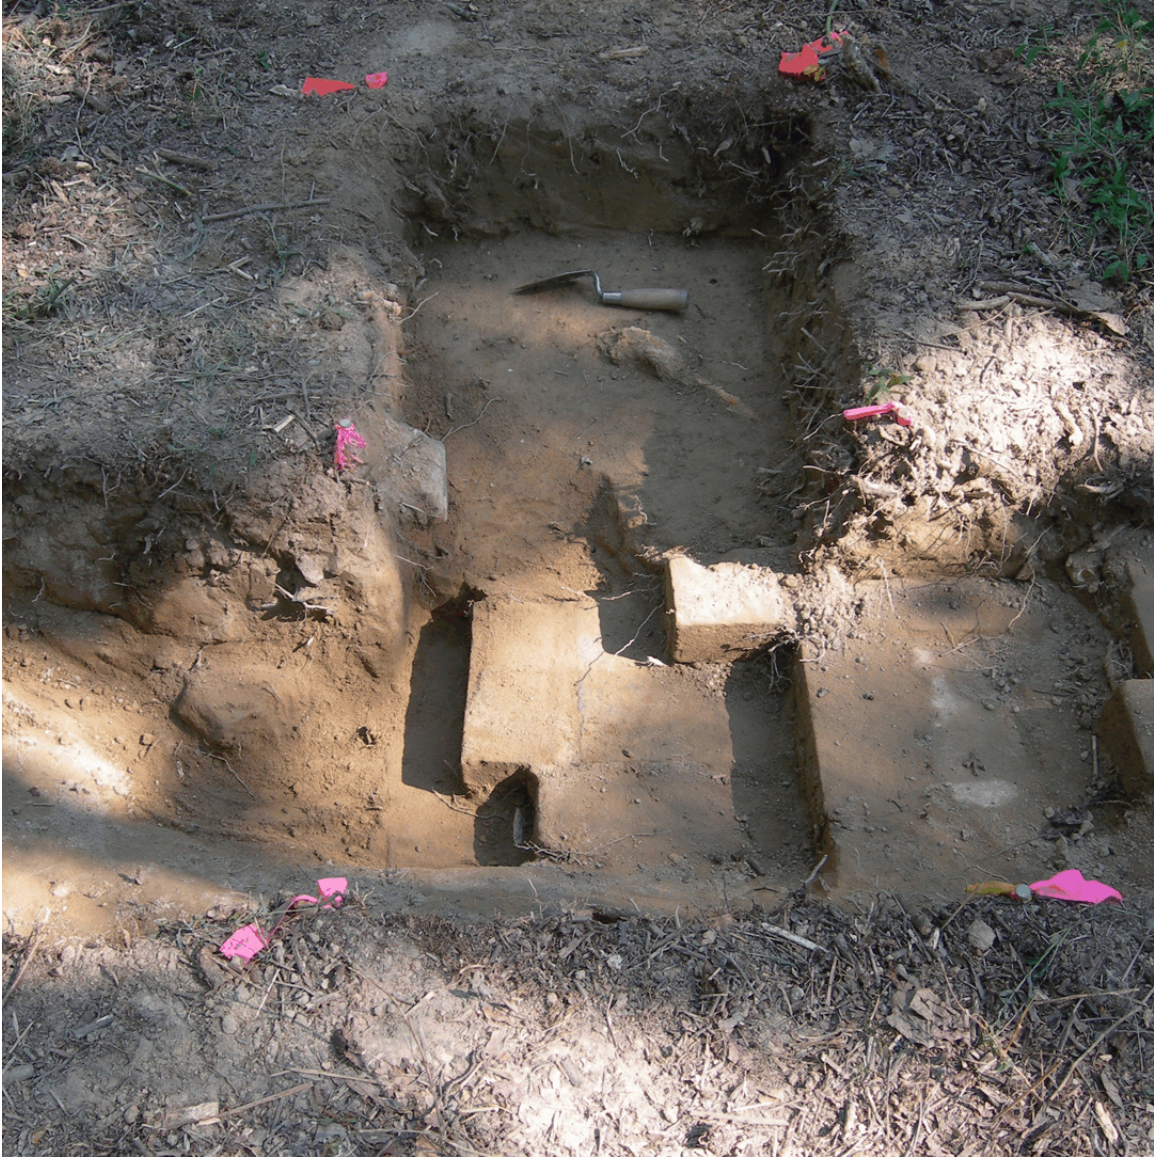
Figure 4.34. Northwest corner of the Structure 2E foundation, facing east.

At the projected location of the northeast corner, excavation again revealed the absence of brick work. However, similar to the northwest corner, the soils indicated that the foundation had been dug into from the north (Figures 4.35 and 4.40). A single brick extended into the southwest corner of N1156E1020 at the base of the excavation, and the fill matrix in that section of the test unit was interspersed with small fragments of mortar which had been scraped off the brick which had been removed. Except for the mortar fragments around the single brick, the soils were the same as those noted at the northwest corner.

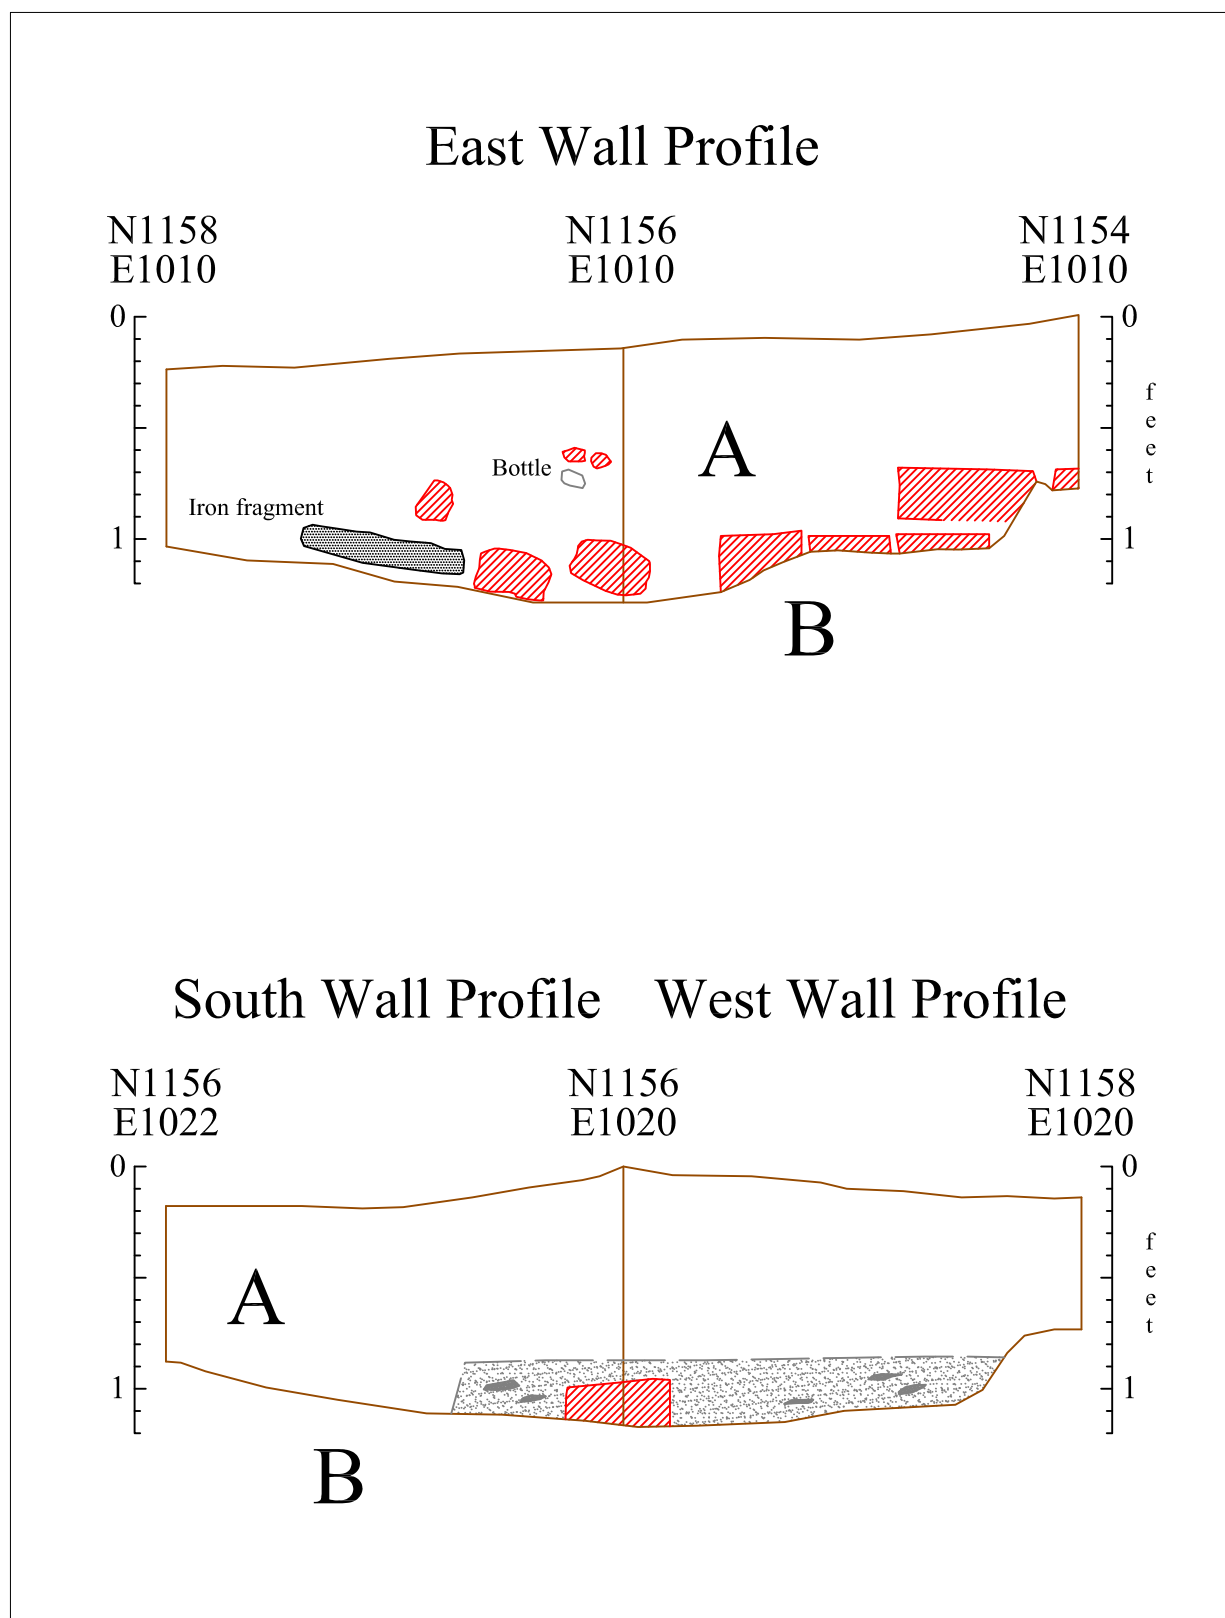
Figure 4.35. Structure 2E north end profiles.

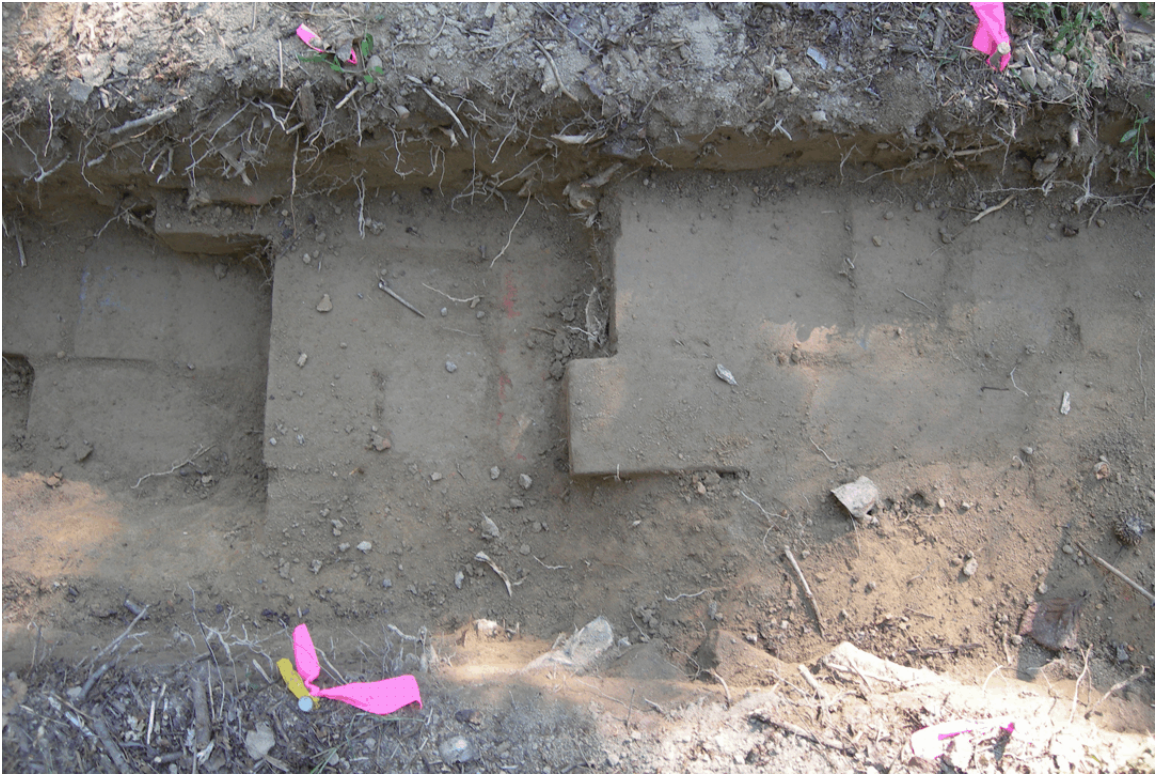
Figure 4.36. Detail of the west foundation of Structure 2E (top towards the east).

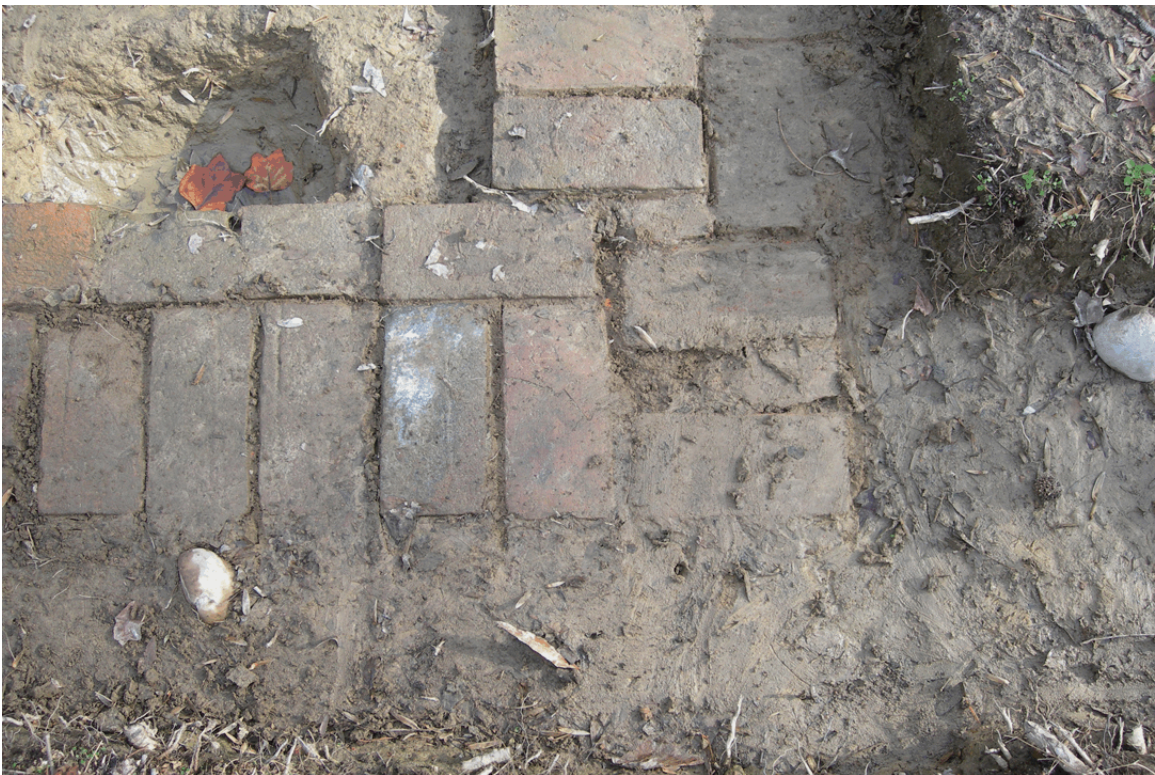
Figure 4.37. The southwest corner of Structure 2E's foundation, top faces east.

The excavations at the south end of the west wall uncovered an intact corner (Figure 4.37). Brick fragments had been employed to facilitate the "interlocking" of the west and south wall brickwork. To the south of the corner, some small cobbles occurred suggesting the possibility that some sort of cobble paving may have once occurred along the south side. (The absence of any apparent depth to the cobbles precluded its interpretation as a possible French drain.) The south wall, as had the west wall, had been placed directly into a trench with no excess excavation along the south side of the wall. The location of the southwest corner in conjunction with the approximate location of the northwest corner indicated a length of about 14 feet along the west wall (Figure 4.38).

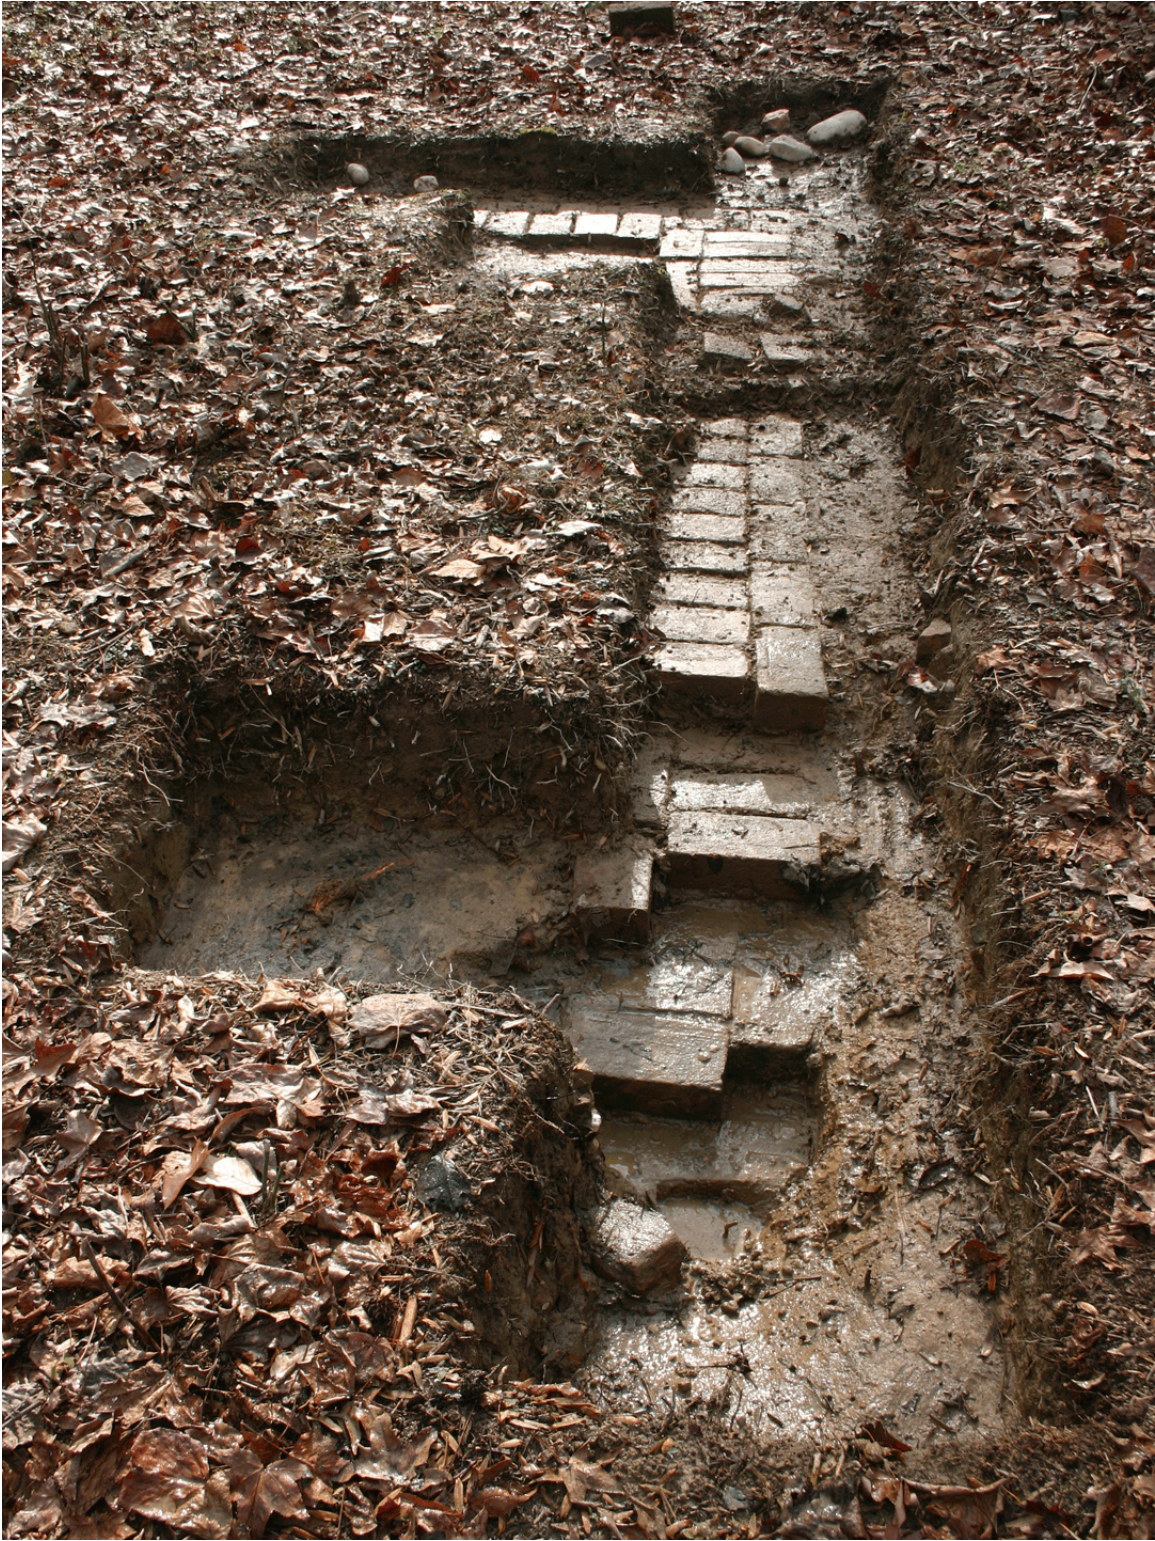
Figure 4.38. Structure 2E's west foundation wall, facing south.
