253)
Archeological Investigations at the Lexington Plantation Site,
 44FX736

Mason Neck State Park
 Commonwealth of Virginia
 Fairfax County, Virginia

Fairfax County Park Authority
 Resource Management Division
 Cultural Resource Management and Protection Section
 2855 Annandale Road
 Falls Church, Virginia
 2008

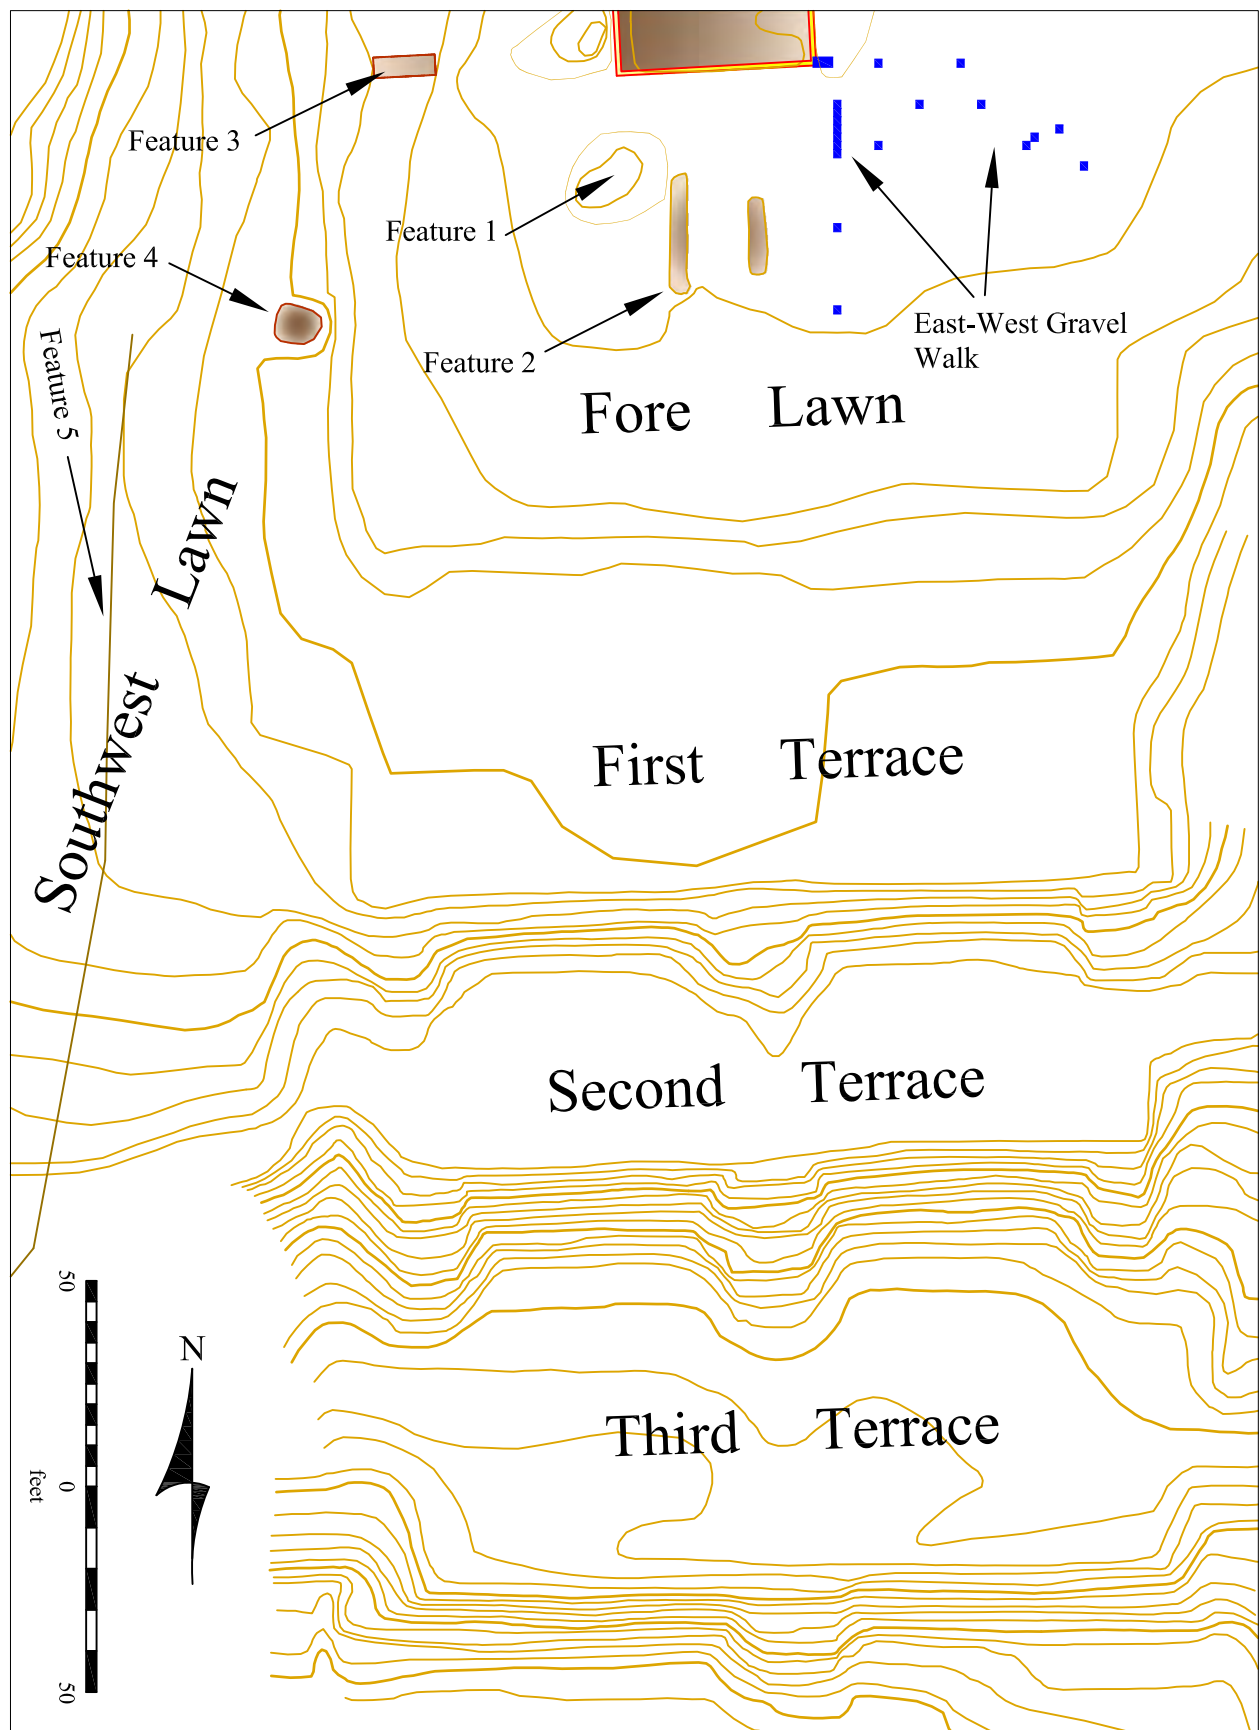
Figure 5.7. Archeological features within the Fore Grounds.

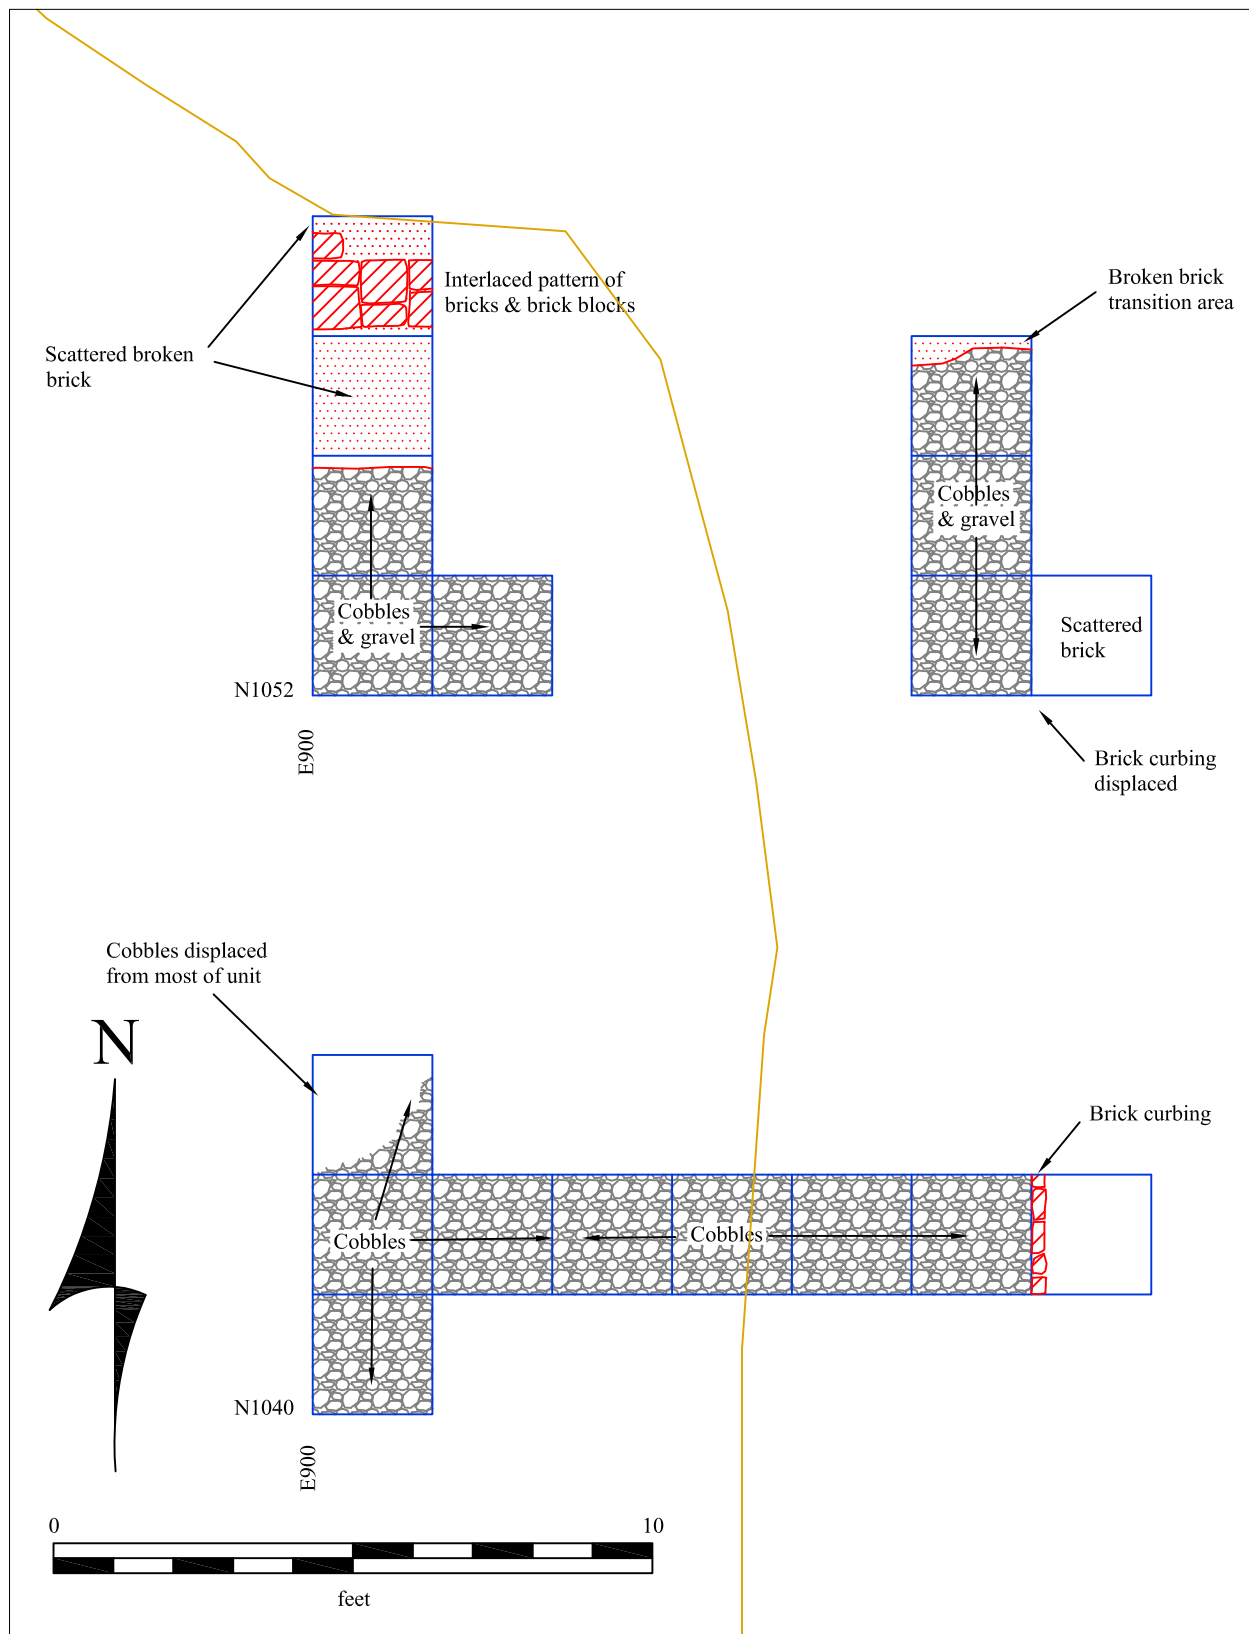
Figure 5.35. Archeological site plan for the area south of Structure 1W.

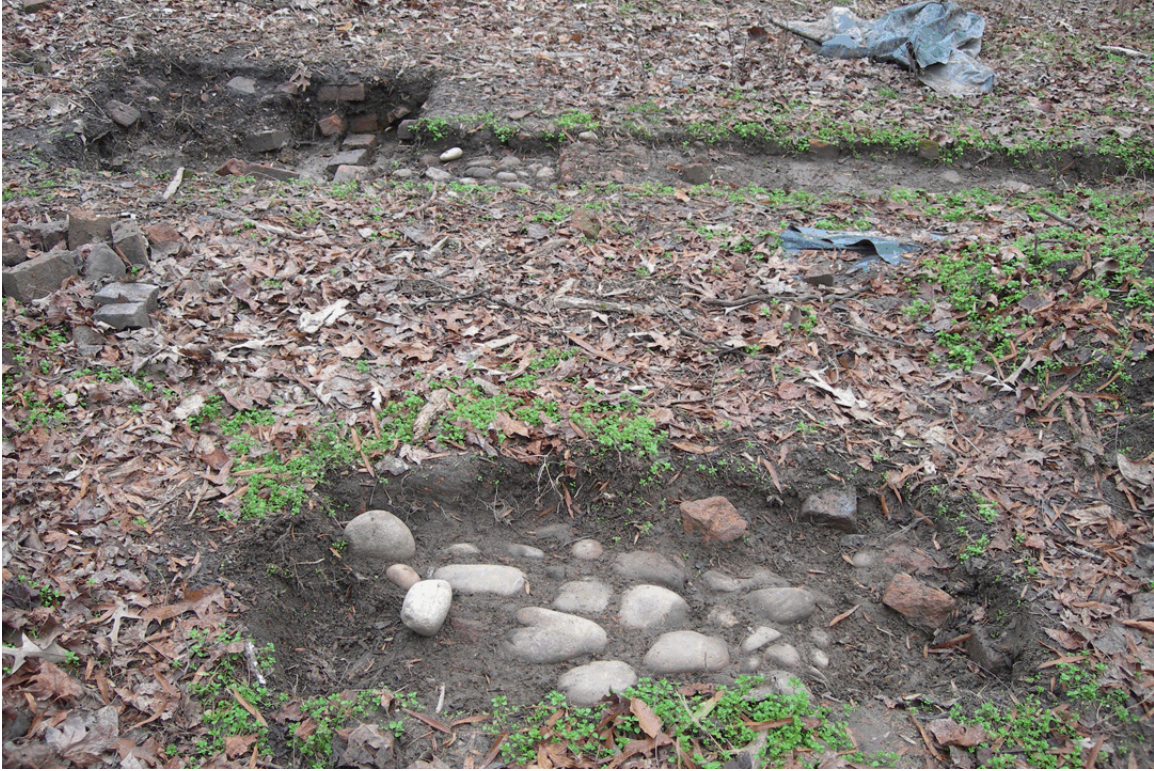
Figure 5.46. Cobble walk, facing east (N1066 & N1064E1012 in foreground; Structure 1E brick and cobble pavements in background).

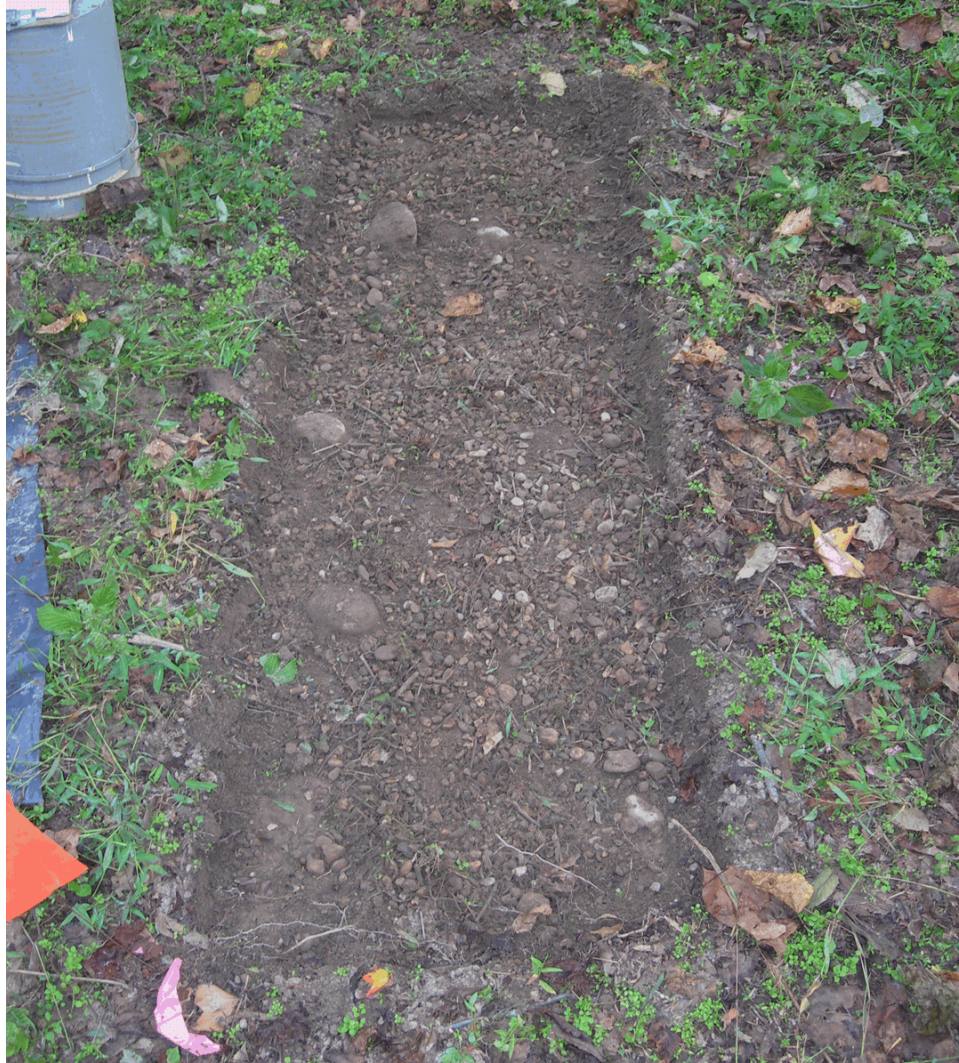
Figure 5.47. Gravel entry road: N1060E960, N1062E960, and N1064E960 (top faces north).

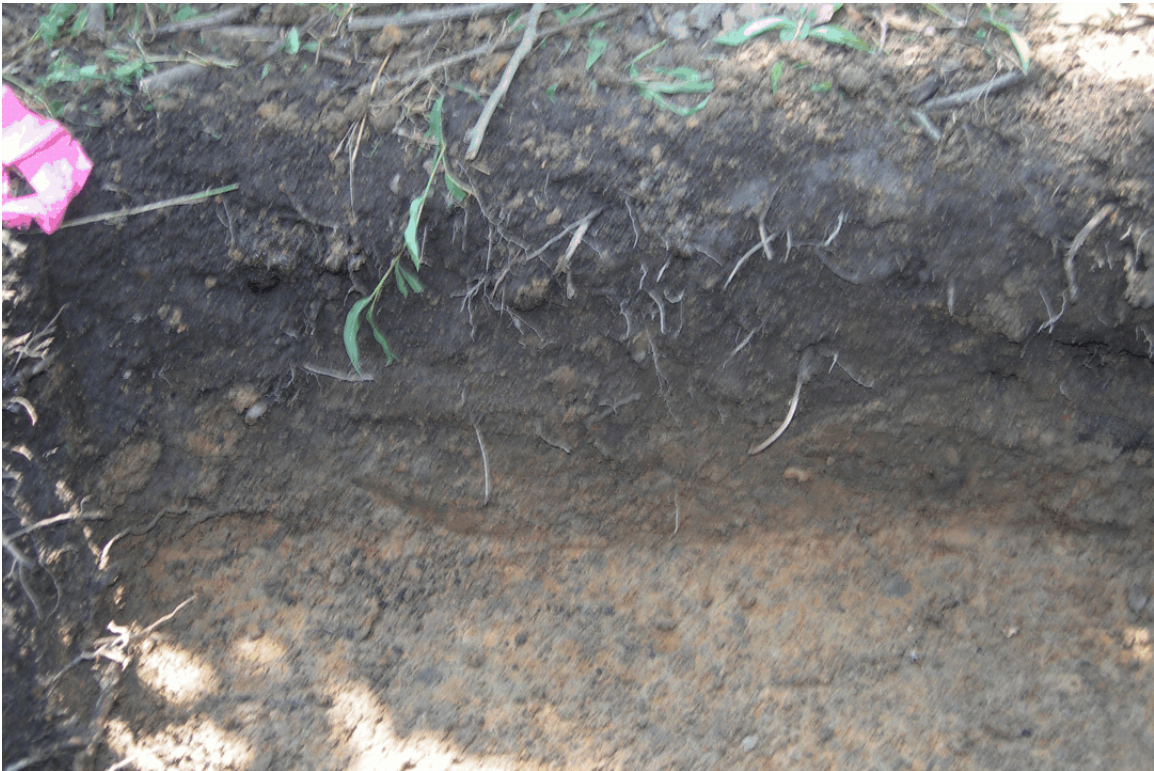
Figure 5.51. Charcoal stained soils in the south wall profile of N1040E880.

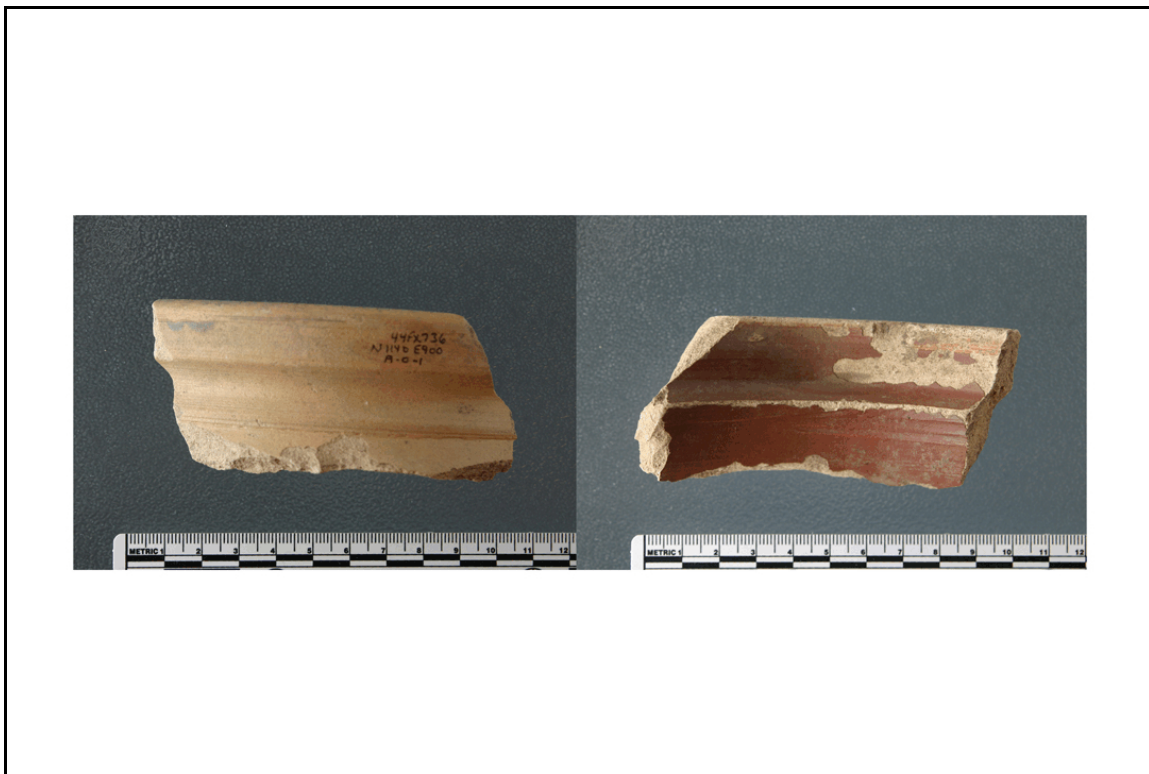
Figure 7.15. Terra cotta drain tile, N1140E900A-0-1.

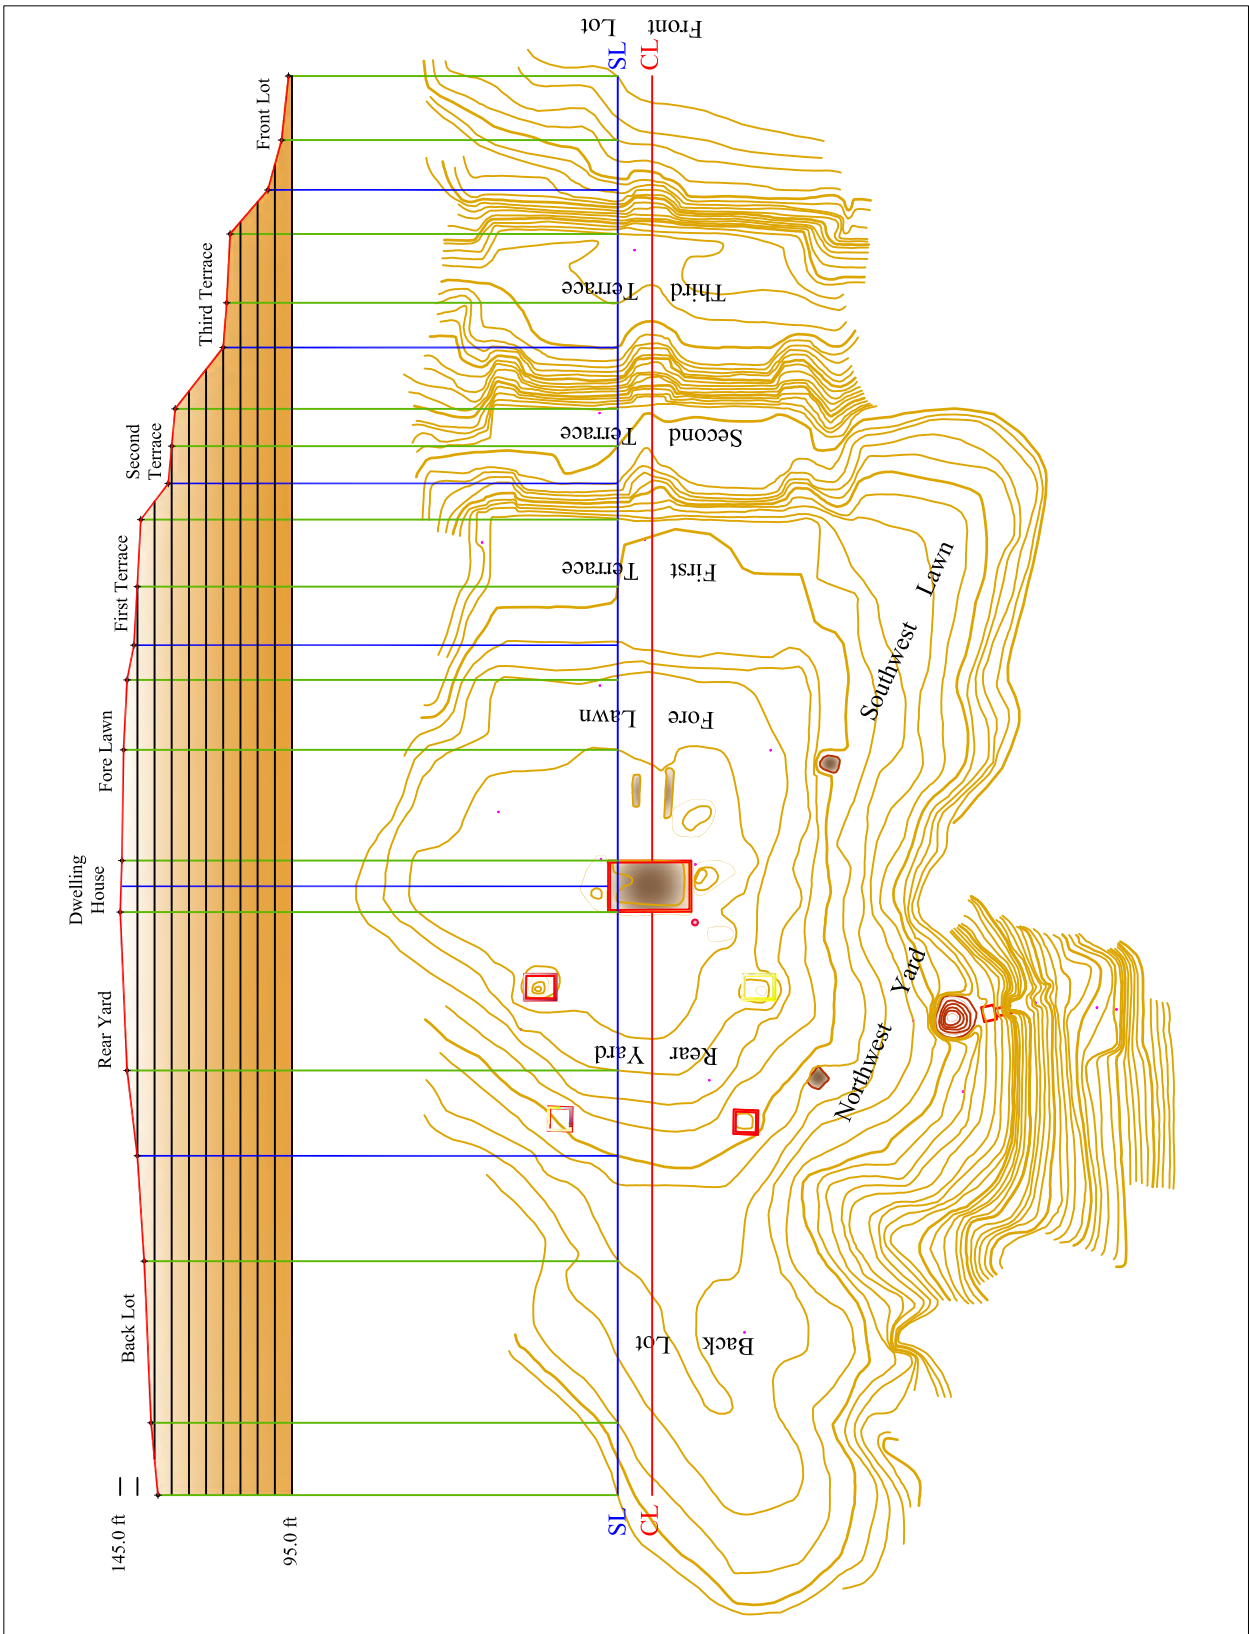
Figure 8.1. Cross section across the Lexington home site.
